**MICROPILE FOUNDATION REPAIR AND UNDERPINNING, ARTS AND SCIENCE MUSEUM,  
UNIVERSITY OF PUERTO RICO, MAYAGUEZ**

Presented at: International Society of Micropiles (ISM)

The International Workshop on Micropiles, 2007

Authored by: John R. Wolosick, P.E.

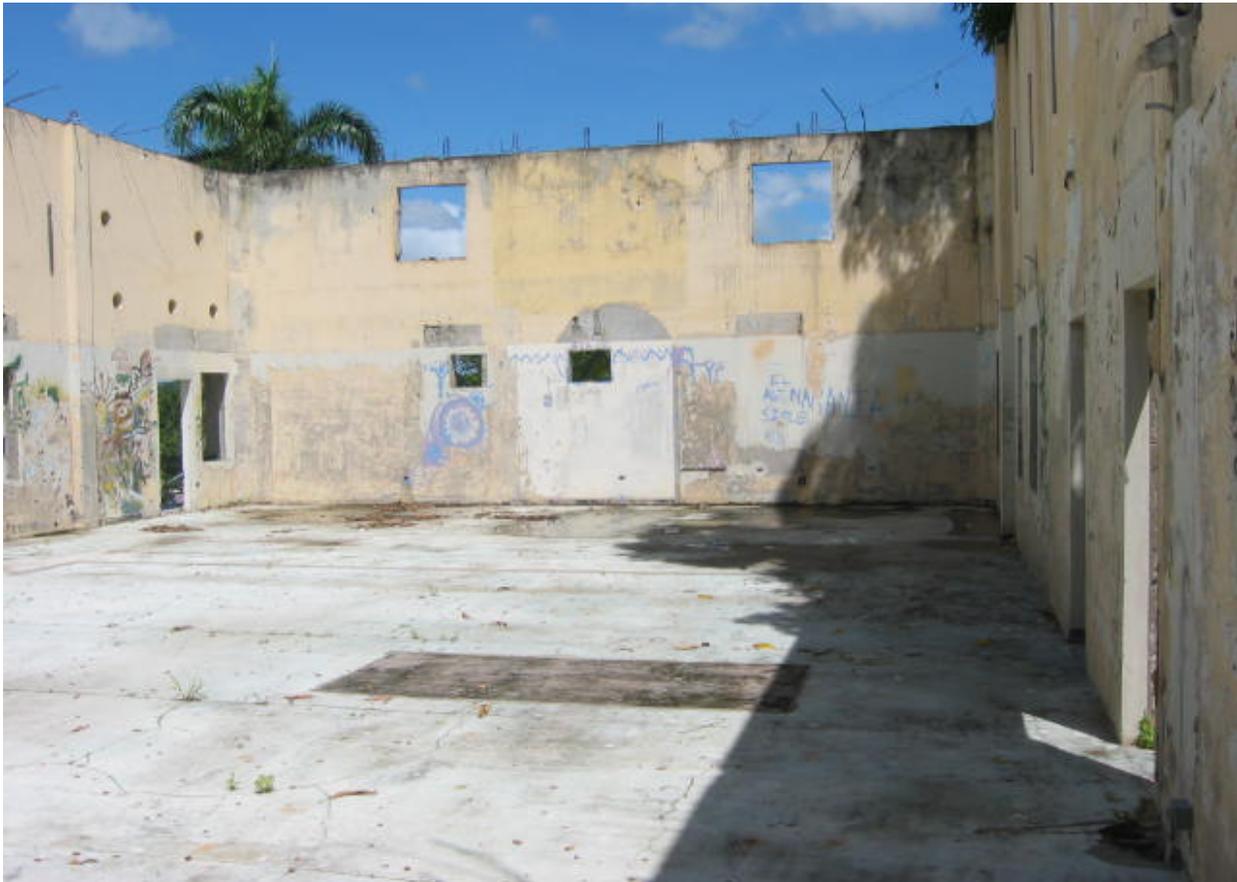
**Figure 2**

The entire roof of the structure was completely torn off by the hurricane, leading to total destruction of the contents of the building. Figure 2 shows the structural damage following the hurricane. Reconstruction plans required several years. Construction was begun in 2005. The renovation design required new and separate support of the proposed new roof structures since it was determined that the original walls could not support the proposed loadings. Due to the confined access as well as low headroom conditions at many locations, micropile foundations were selected to support the new roof structures.

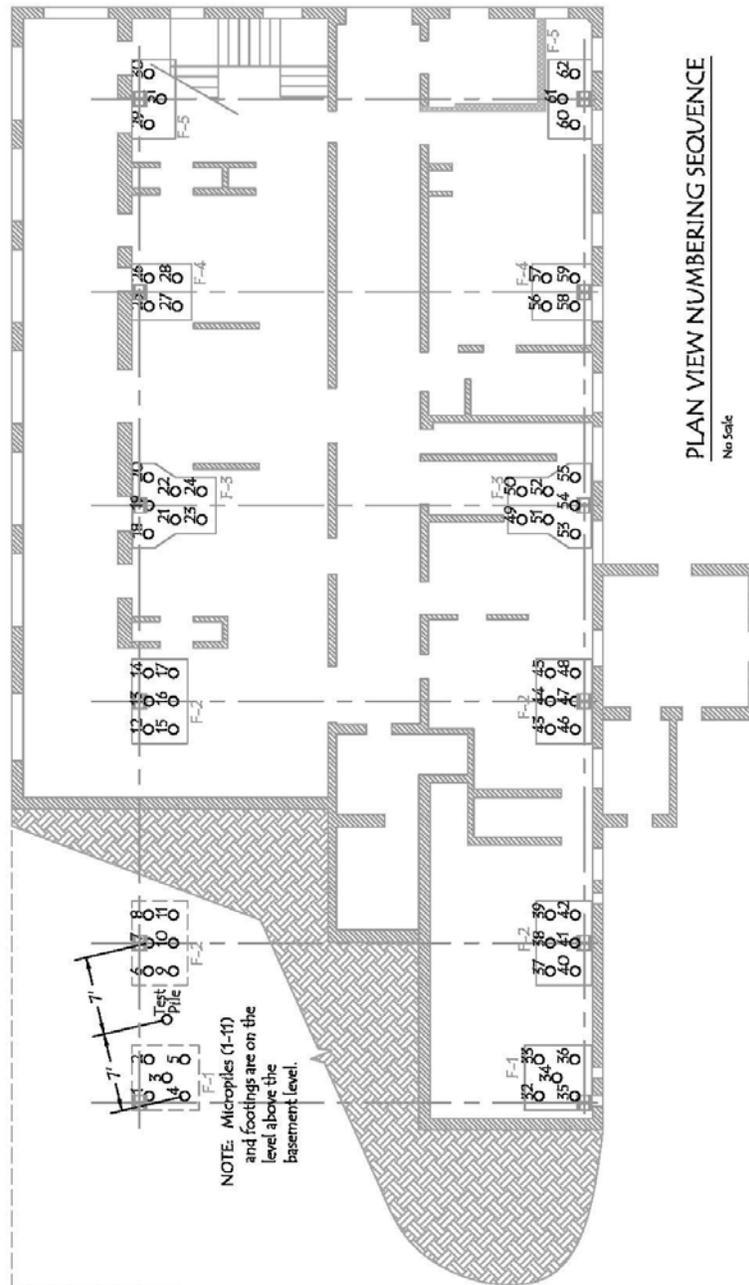
The micropile foundation construction was initiated at the beginning of the reconstruction project. A total of 62 micropiles were installed. Most of the micropiles were constructed in limited headroom conditions. See Figure 3 for the plan view micropile layout. Access to the main level piles was obtained by lifting the drill rig with a crane and setting it within the roofless building. The basement piles were accessed by tramping the drill rig down the basement hallway.

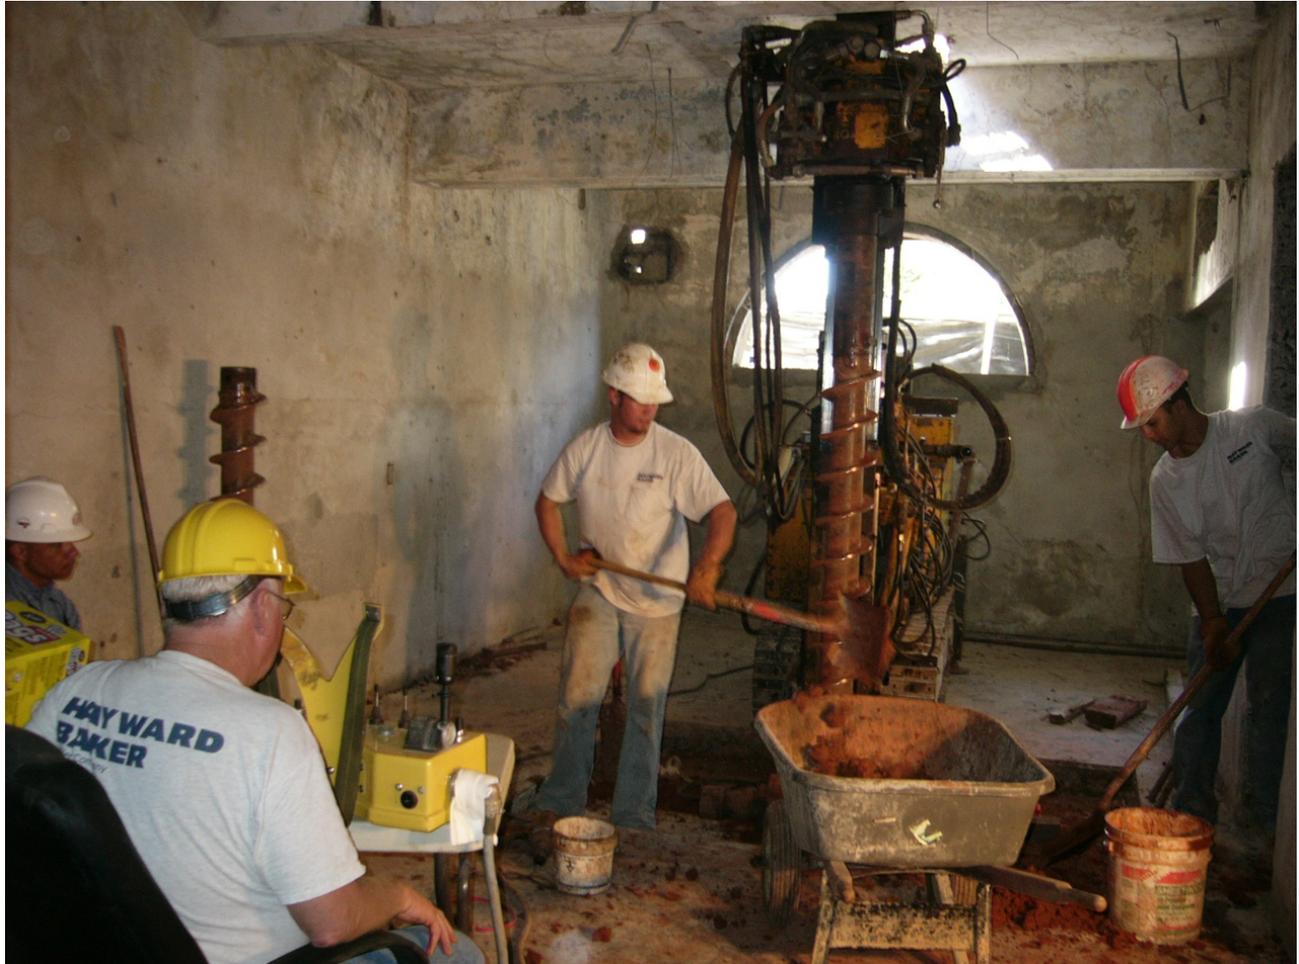
Design loads for the micropiles were 25 tons in both compression and tension. Hollow stem augers were used to drill the piles. See Figure 4 which shows drilling in low headroom conditions. After drilling, the piles were tremie grouted using a neat cement grout with a water/cement ratio of 0.45. The micropiles were reinforced with a full-length Grade 95 (655 MPa) #11 steel bar. The bars were placed in 5 foot (1.5 m) sections in the low-headroom conditions and coupled together as they were placed down the drill hole. Multiple sleeve post-grouting pipes (tubes-a-manchette) were attached to the steel reinforcing bar as it was lowered in the drill hole.

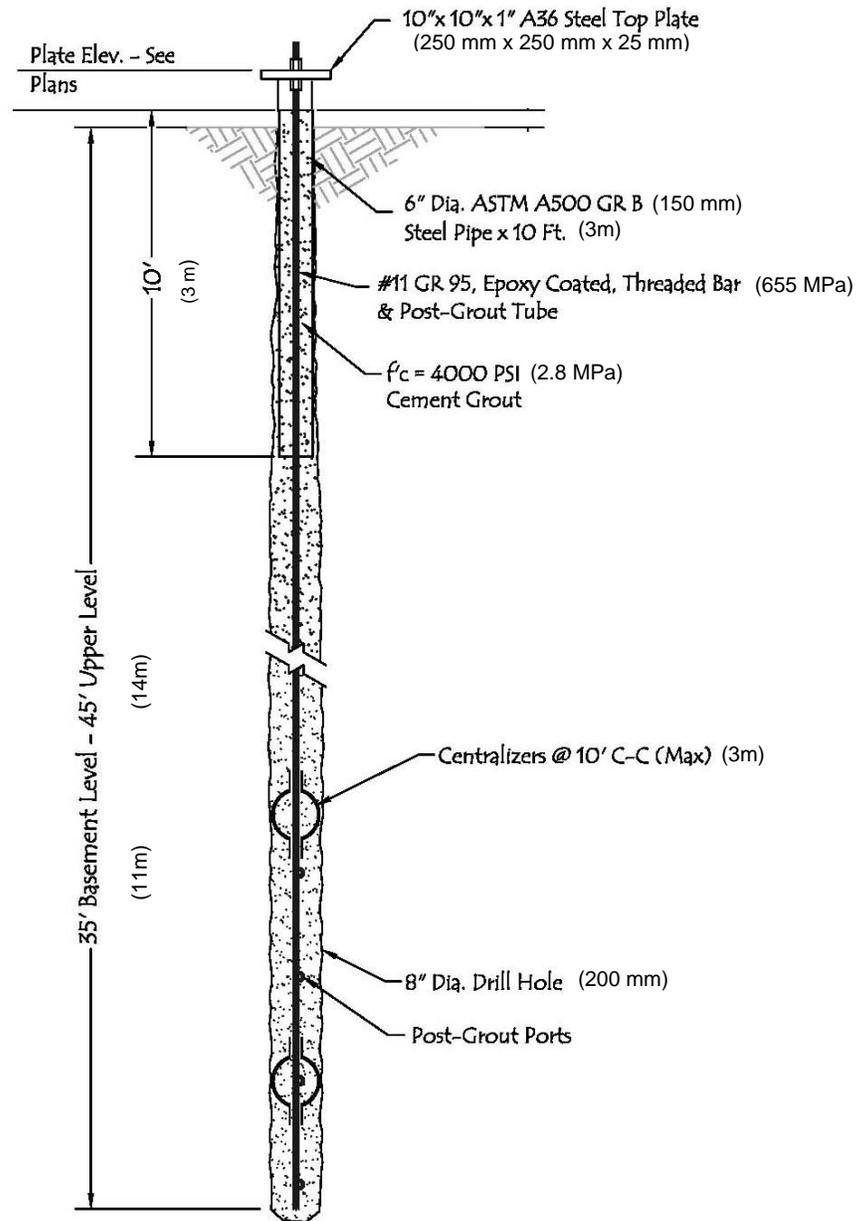
**Figure 5**

In addition, for simple attachment to the piles caps, a thin-walled steel pipe, 10 ft. (3 m) long, was placed into the wet grout at the top of each pile. This pipe acted to confine the grout around the reinforcing bar and provided a tidy pile butt. A bearing plate was also included since the piles were also designed to resist uplift forces. See Figure 5 for a typical micropile cross-section.

TYPICAL 50 kip MICROPILE DETAIL

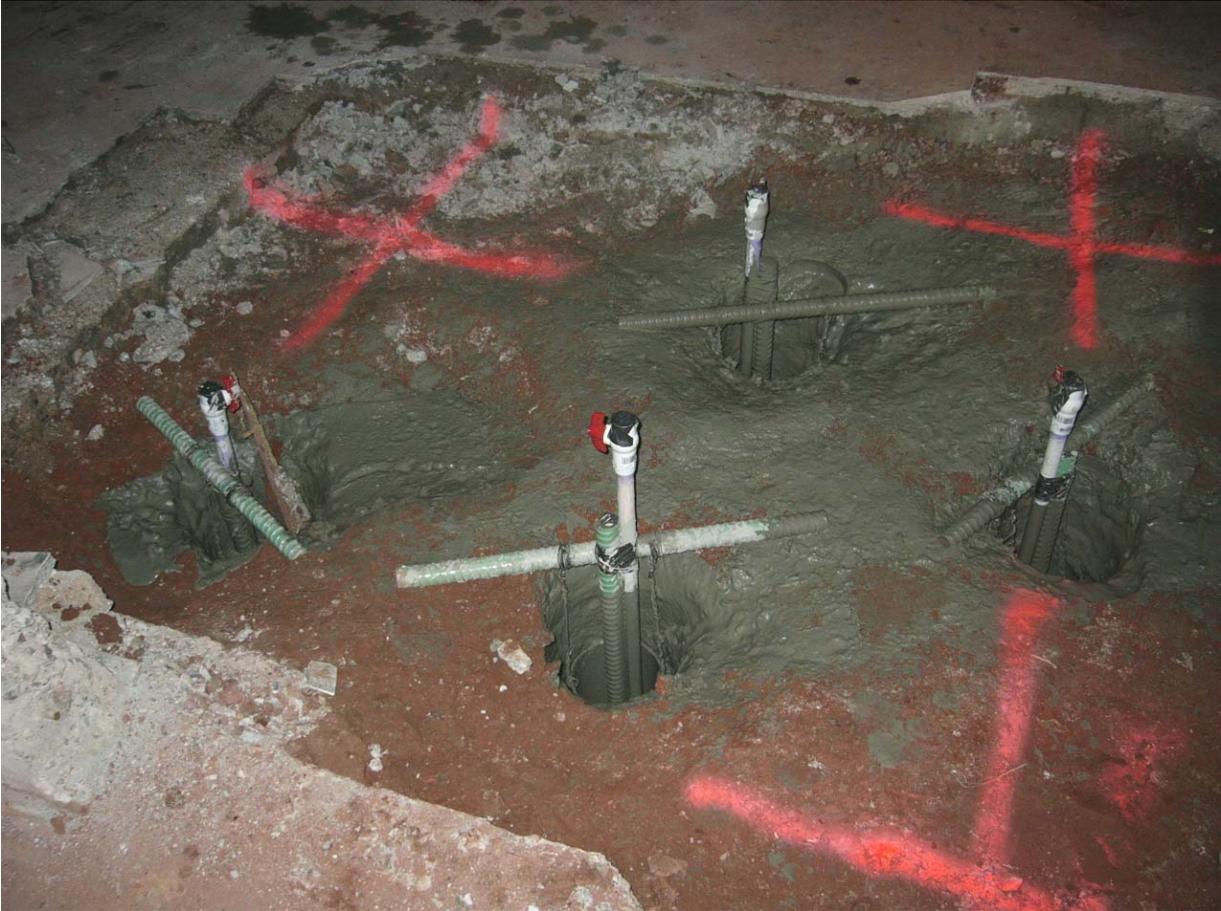
**Figure 6**

Figure 6 shows a typical pile cap layout, prior to excavation for the cap. The Figure shows the drill hole, the post-grout tubes with PVC petcocks at the top, the full-length steel reinforcing bars and a short piece of bar that is wired to the 10 foot (3 m) long, thin-walled steel pipe. This wire suspends the steel pipe at the top of the pile.

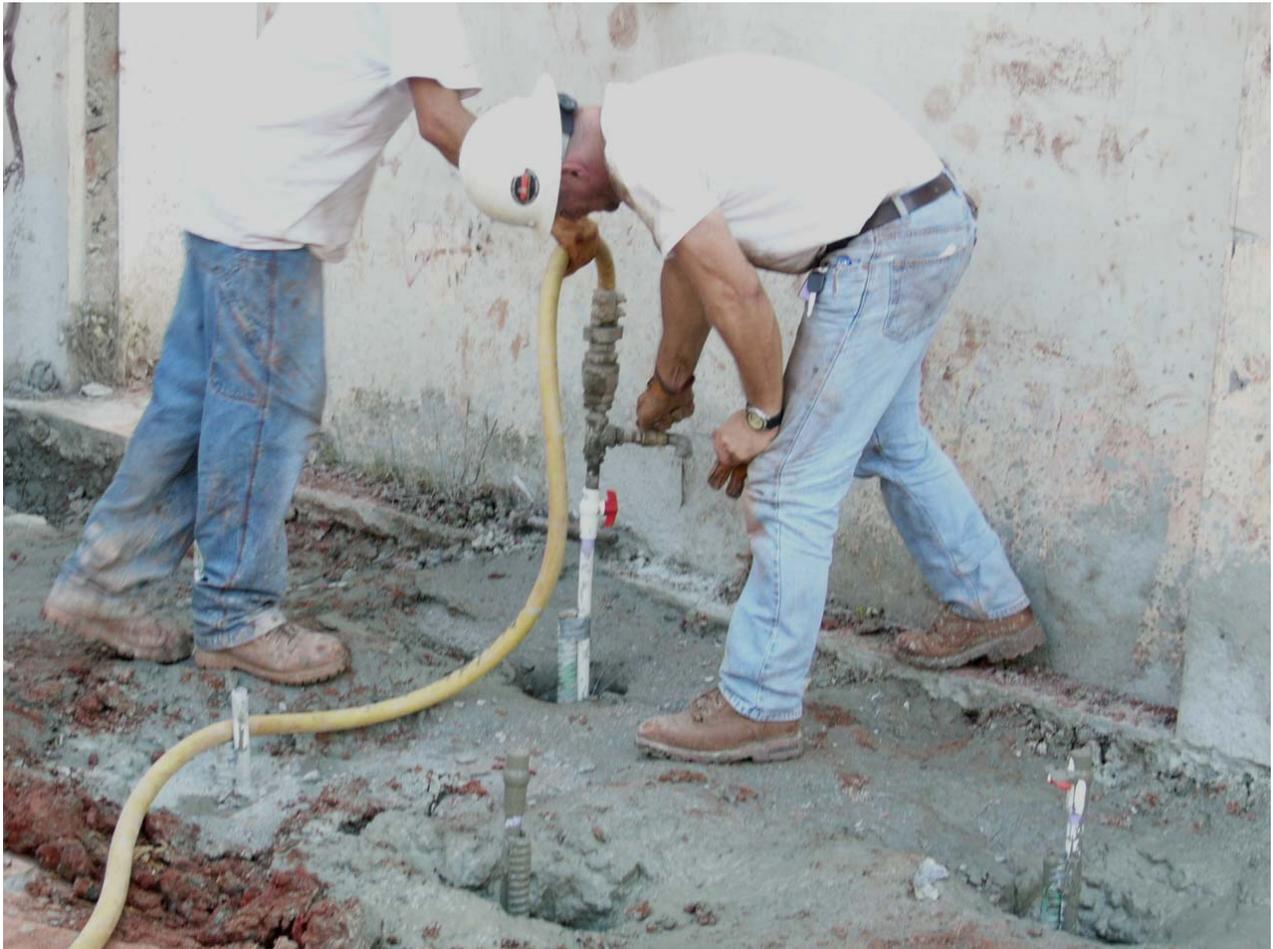
**Figure 7**

Post-grouting of the piles was prescribed to obtain the design loads in the soft silt utilizing an 8 inch (200 mm) diameter drill hole and a 25 foot (7.6 m) long bond zone, located below the fill layer. Therefore, the total pile lengths were 35 feet (10 m). The post-grouting was generally performed the day after pile installation. Approximately 5 cubic feet (142 liters) of cement grout was injected, using a high-pressure hydraulic piston pump, from the top of the pile. The piston pump operated off of the hydraulics of the skid-steer loader. The loader was used to carry the pump from pile cap to pile cap. Typical post-grouting break-out pressures were 300-350 psi (21-25 bar). Continuous pumping was observed at about 250 psi (17 bar). See Figure 7, which shows the post-grouting procedure.

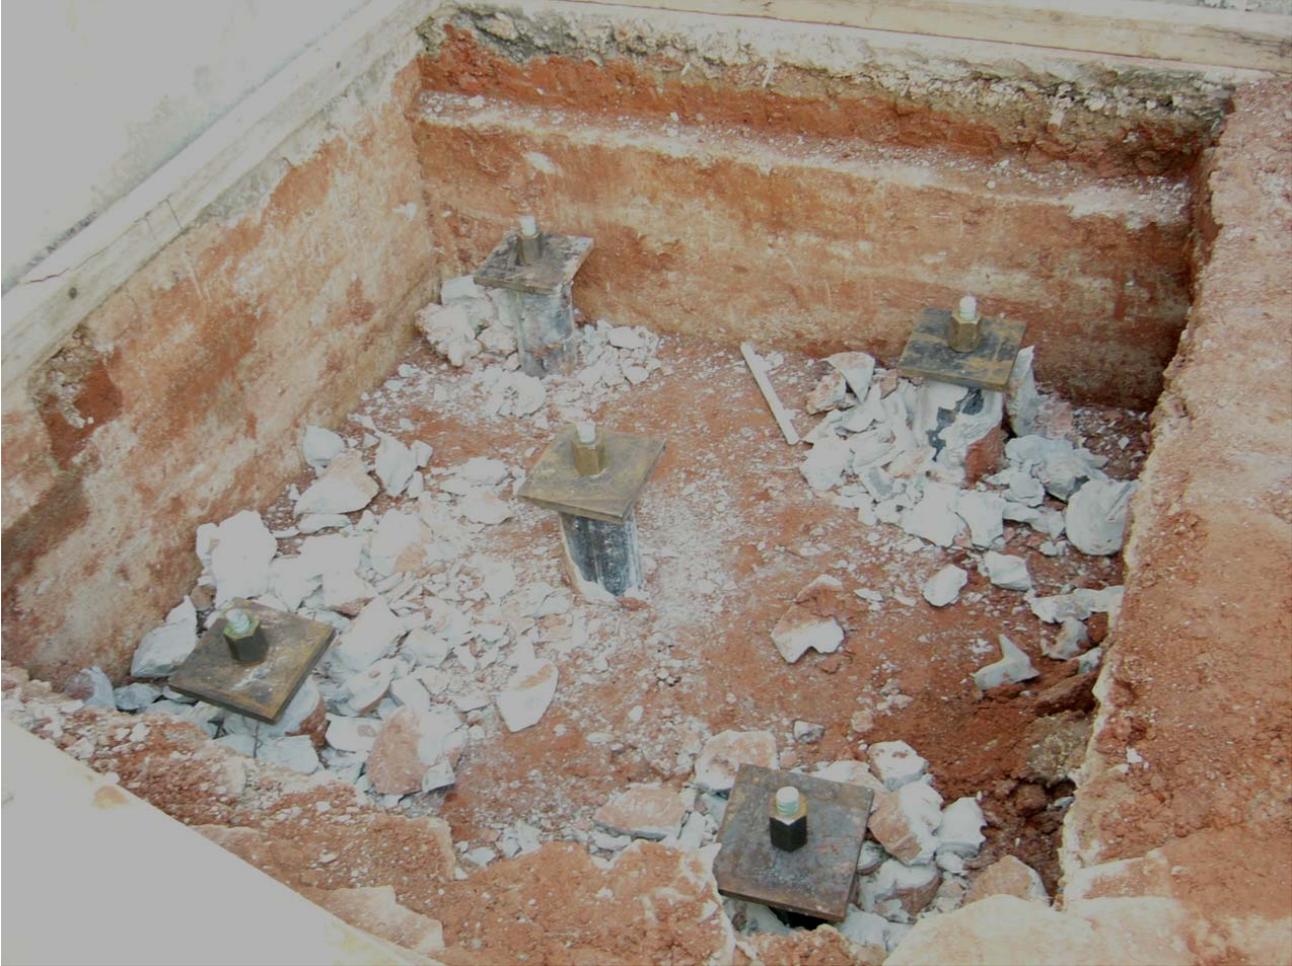
**Figure 8**

Figure 8 shows excavation for the pile cap and the final micropile configuration after the bearing plates have been attached.

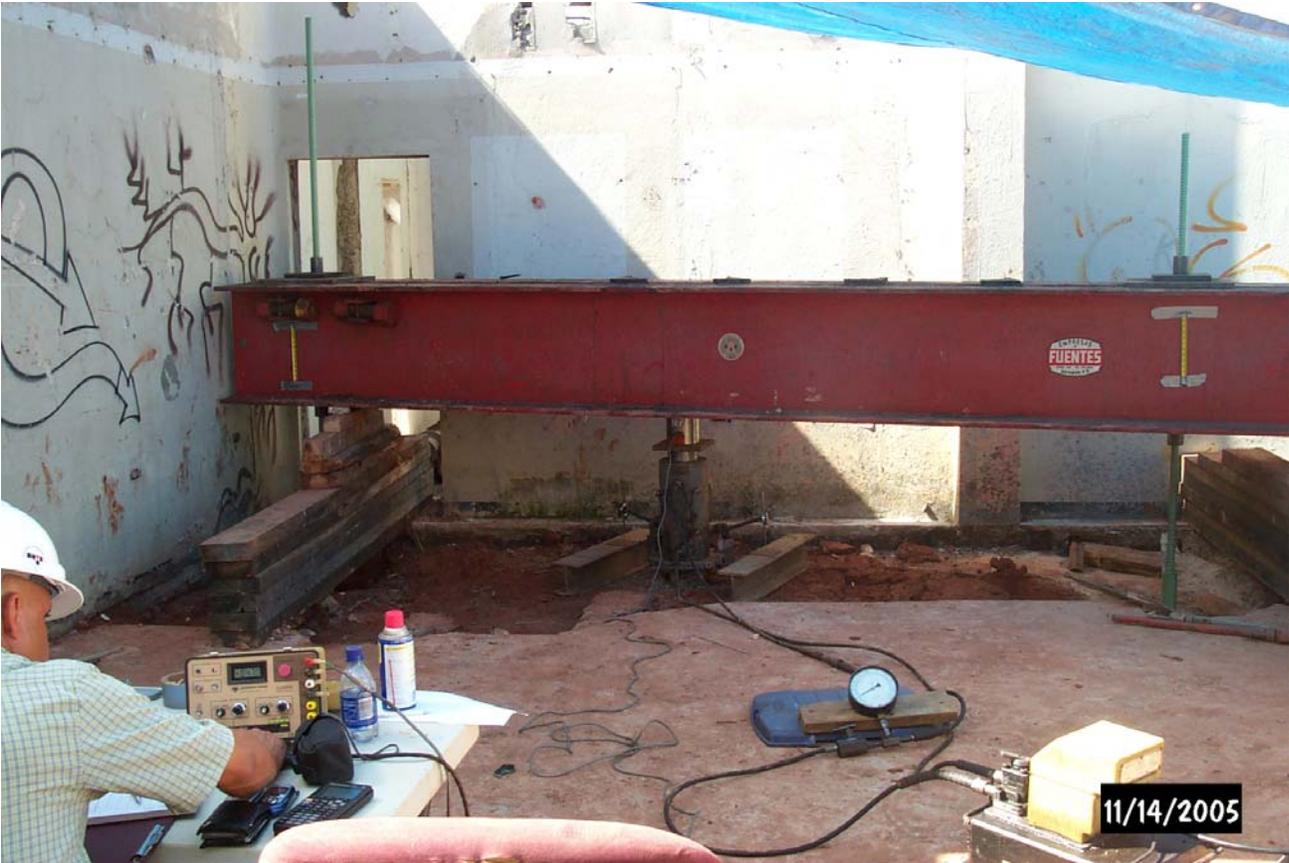
**Figure 9**

An initial load test, utilizing drilled and post-grouted tie-down anchors was completed on a sacrificial pile, located within the building on the first floor. Production micropiles were used for the reaction anchors to support the test beam. Therefore, the tension resistance of the piles was also proved by monitoring the tension reaction piles. See Figure 9 for an illustration of the test set-up.

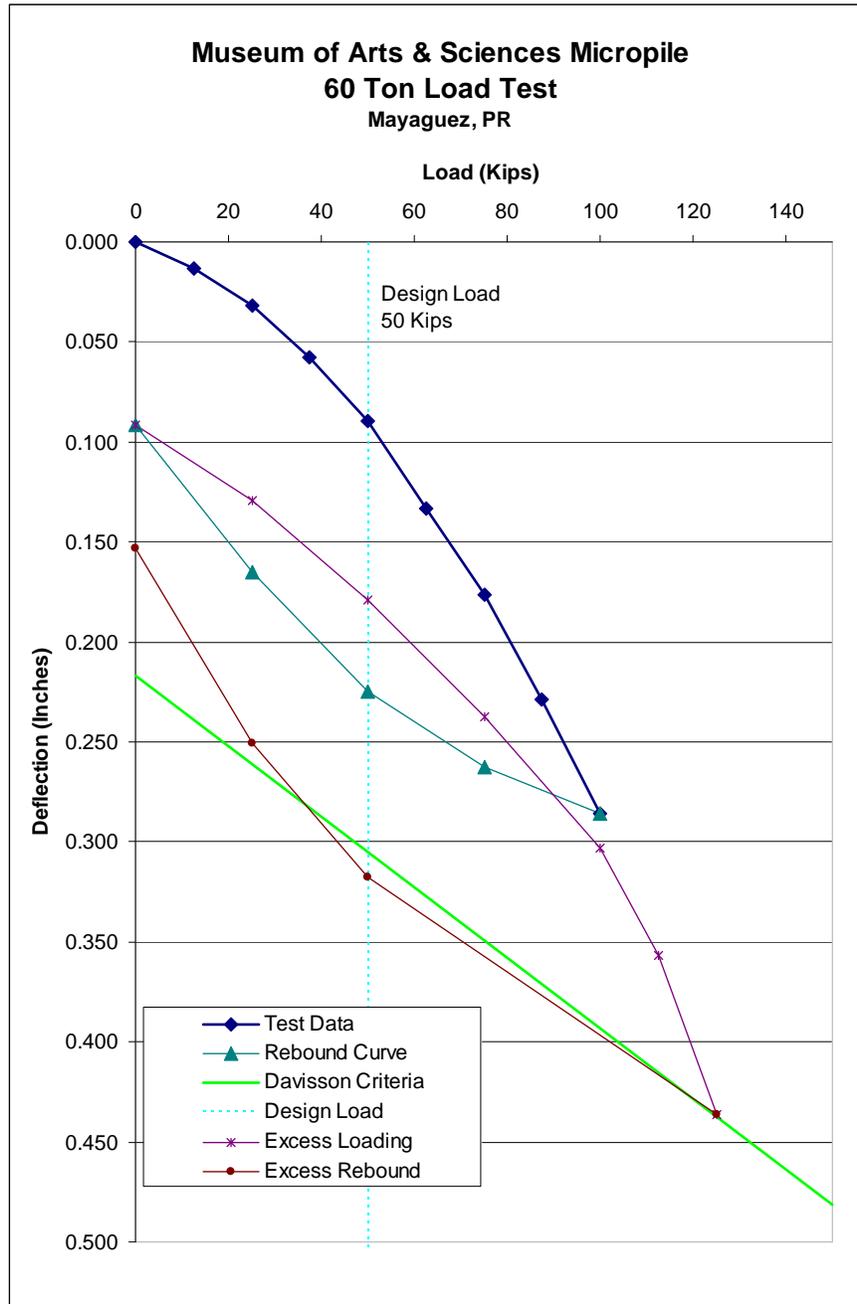
**Figure 10**

The compression test was initially loaded to two times the design load and then rebounded to measure permanent set (0.09 inch, 2.3 mm). Then the pile was loaded to 2.5 times the design load as required by the specifications. A graph of the test is shown on Figure 10. The Davisson criteria line is shown on the graph. This criteria was intersected at 2.5 times design loading at a total deflection of 0.435 inch (11 mm).

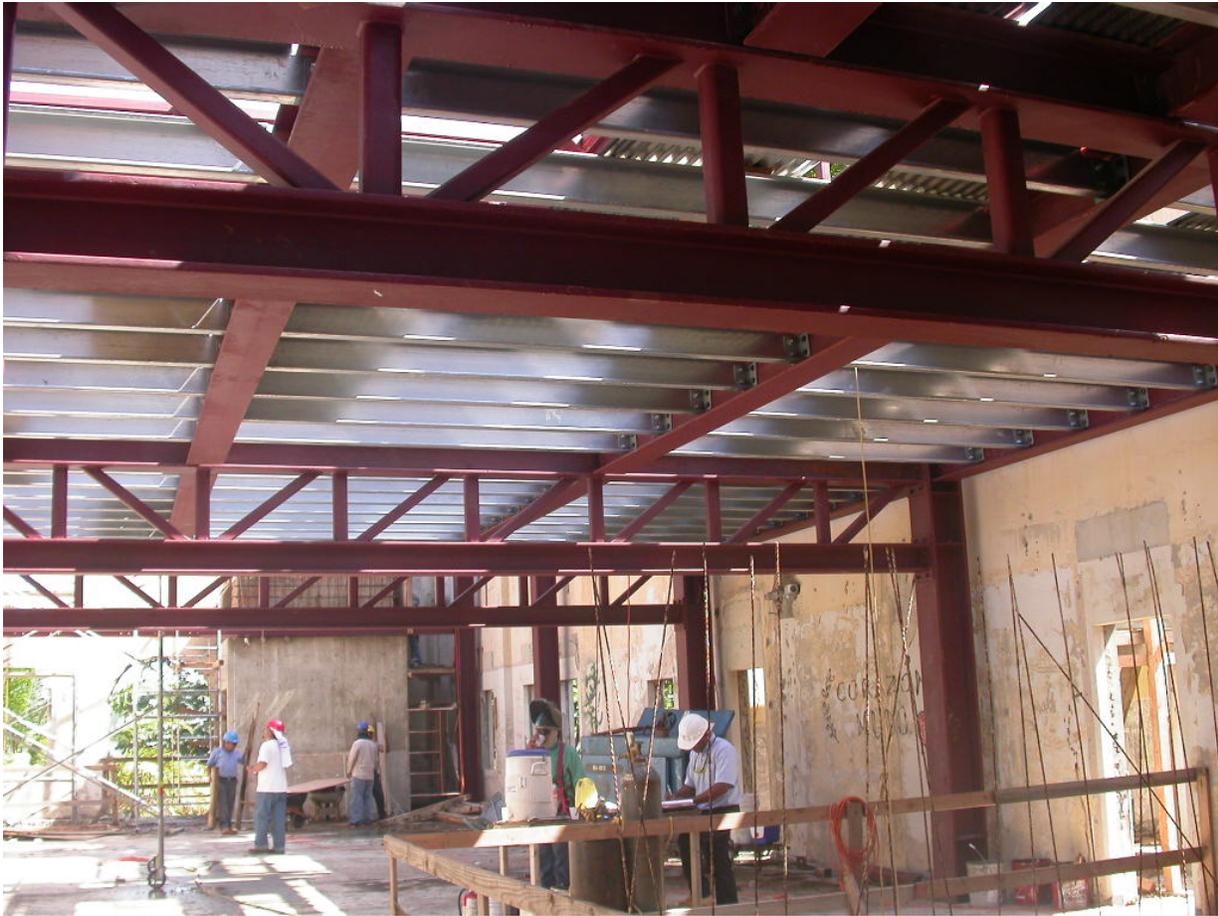
**Figure 11**

The micropiles were completed during the early winter of 2005. Micropiles provided the ideal foundation installation in the confined space and limited access environment to support the new columns and roof structures. Micropiles also allowed for the installation of new columns adjacent to the existing structures with minimum disturbance of the existing shallow foundations. The new columns and roof structure are shown in Figure 11.
