Field Trip Guide Coastal Structures & Erosion Western Puerto Rico Symposium # 34 Marsh 9-12, 2023

by: Wilson R. Ramírez-Martínez, BS, MS, PhD, PG

We will visit several beaches located in the western coast of the island. These sites have been impacted by coastal structures build with different purposes. We will observe and discuss the different aspects involved in each case.

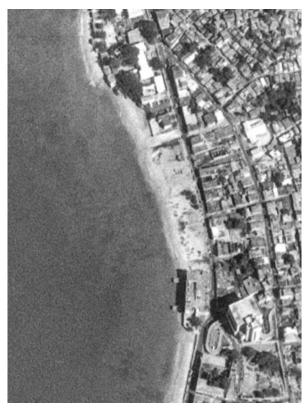
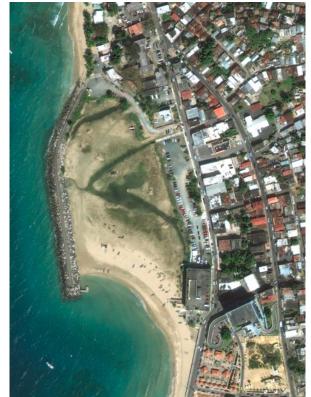
Aguadilla 1993

Aguadilla 2009

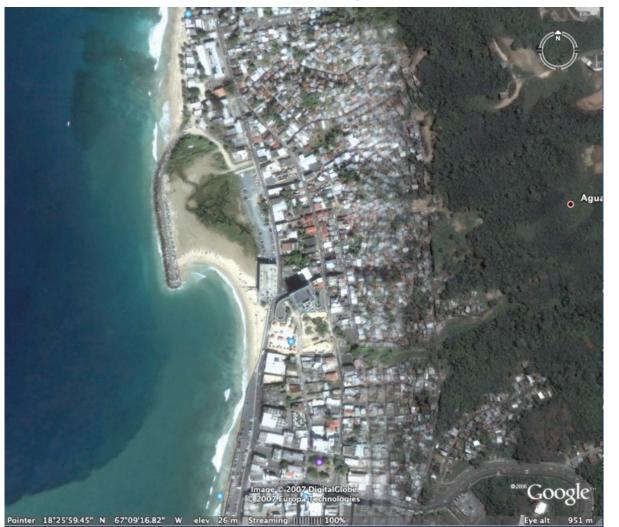
Stop 1: Aguadilla, "Marina"

Wave refraction influenced by the marina breakwater and bathymetric features to the south of the marina has created beach across the entrance to the marina making it useless.

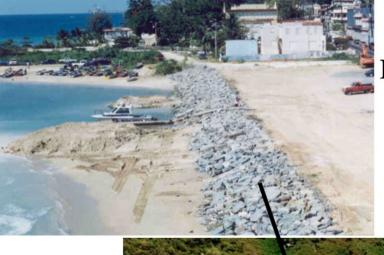
Rompeolas - Muro de Rocas dentro del agua o pared

- Barrera paralela a la costa fuera de la orilla / en el mar
- Protege de la fuerza de olas, creando una zona de menor energía detrás de el muro

Copyright @ The McGraw-Hill Companies, Inc. Permission required for reproduction or display. Erosion (Land) Original shoreline Deposition Breakwater Lines of wave crests

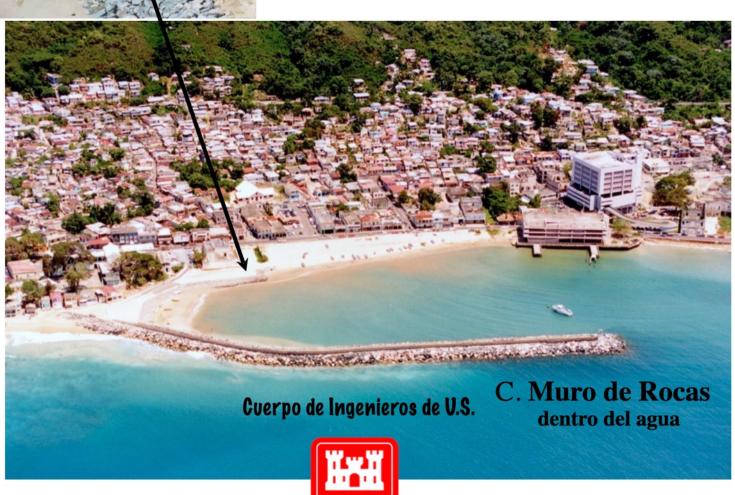
"La Marina" de Aguadilla 1995

B. Muro de Rocas fuera del agua Rip Rap

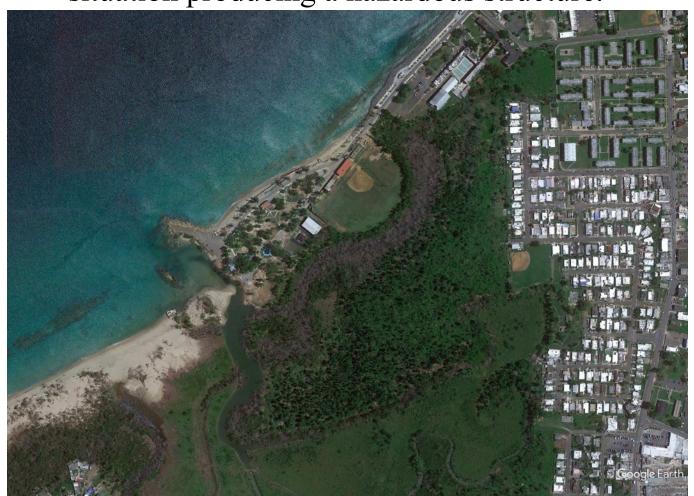
Stop 2: Aguadilla, Parque Colón

Breakwater connected to land was constructed to develop a marina in Aguadilla. Storm and longshore sand drift have rendered the intended marina useless. Lack of maintenance of the structure has aggravated the situation producing a hazardous structure.

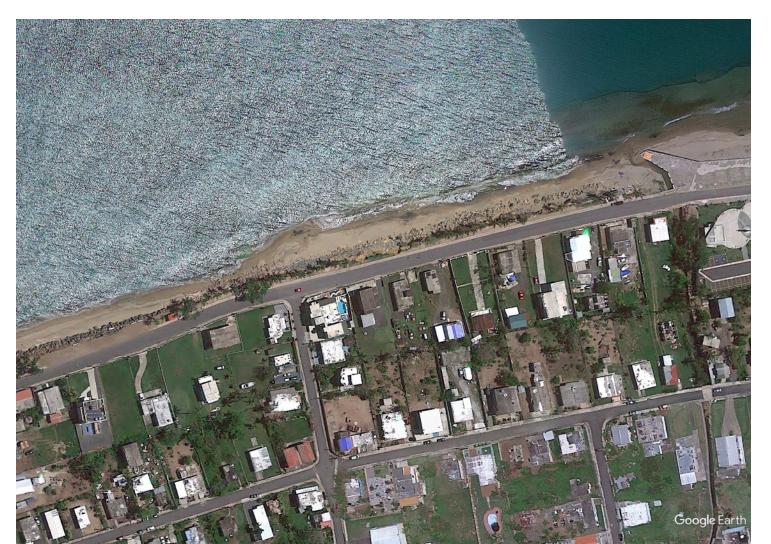
Stop 3: Aguada, Camino Playa (Monumento Historico al Santuario Cruz de Colón)

Rip-Raft build to protect Camino Playa and the properties if front of the beach has produced a high relieve along the coast.

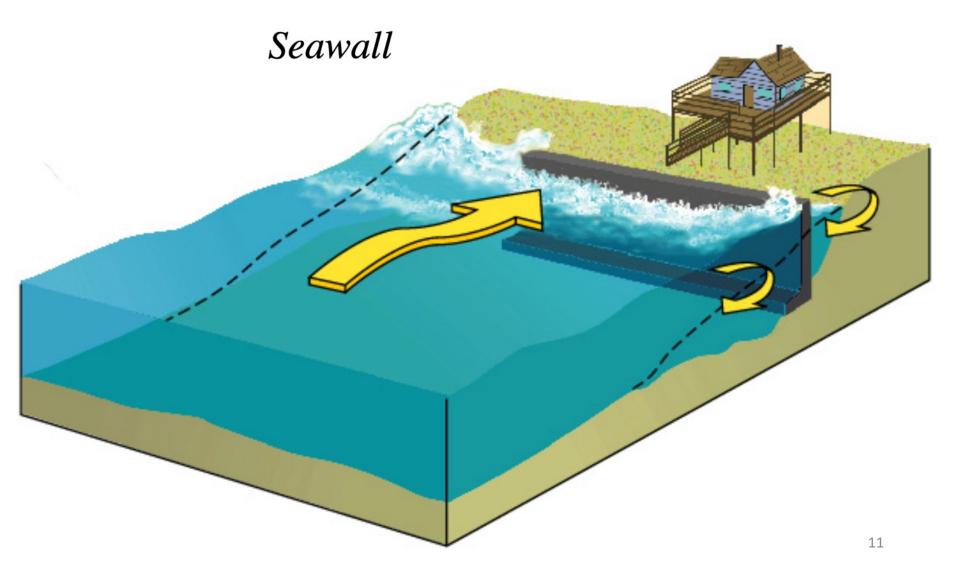
Rompeolas - Muro de Concreto

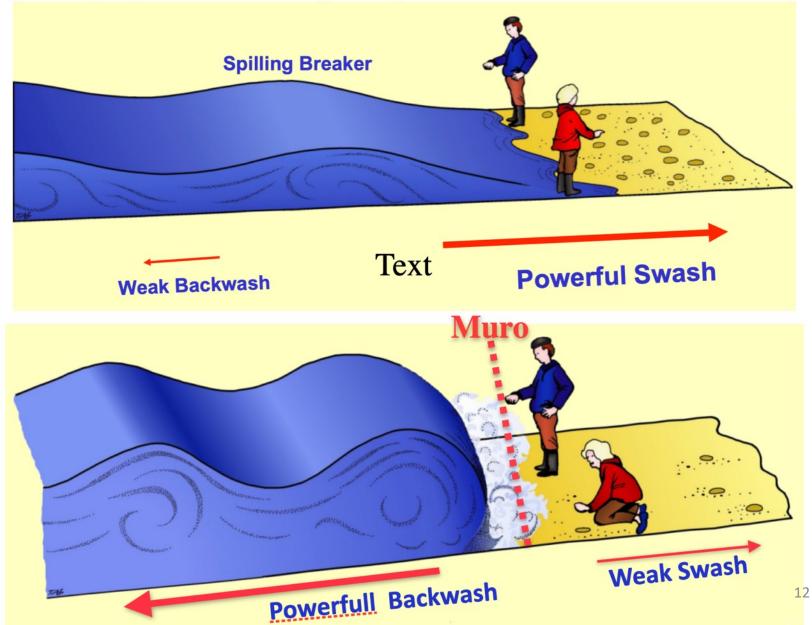
Rompeolas - Muros de Concreto y de Rocas

Protegen la propiedad a corto plazo pero aumentan la erosión en la playa.

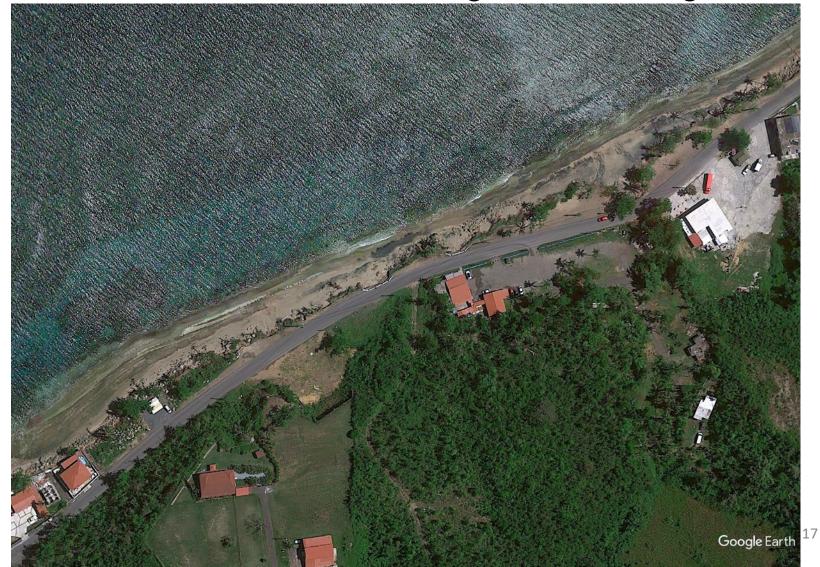
Stop 4: Aguada, Camino Playa (close to Balneario Pico de Piedra)

Loss of sand has exposed large sections of beachrock. Beachrock & beach sand with high content of magnetite.

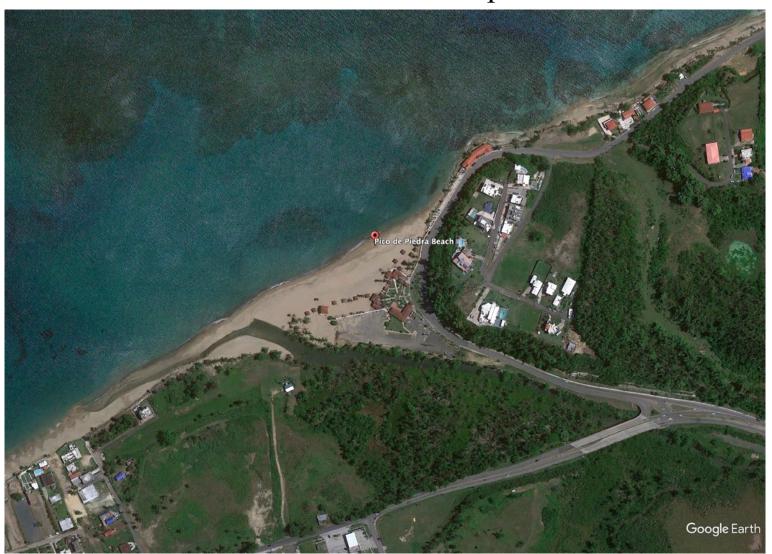
Stop 5: Aguada, Pico de Piedra Public Beach

The eroded beach sand at Pico de Piedra Public Beach was replenished in the 1990's and is still present.

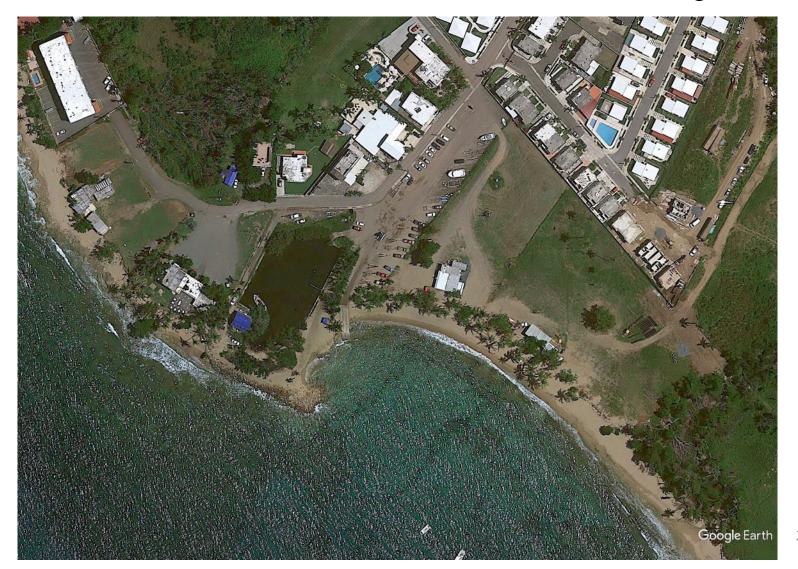
Stop 6: Rincón, Marina Las Palmas

Wave refraction influenced by the marina breakwater and bathymetric features along the offshore southwest created a beach across the entrance making it useless.

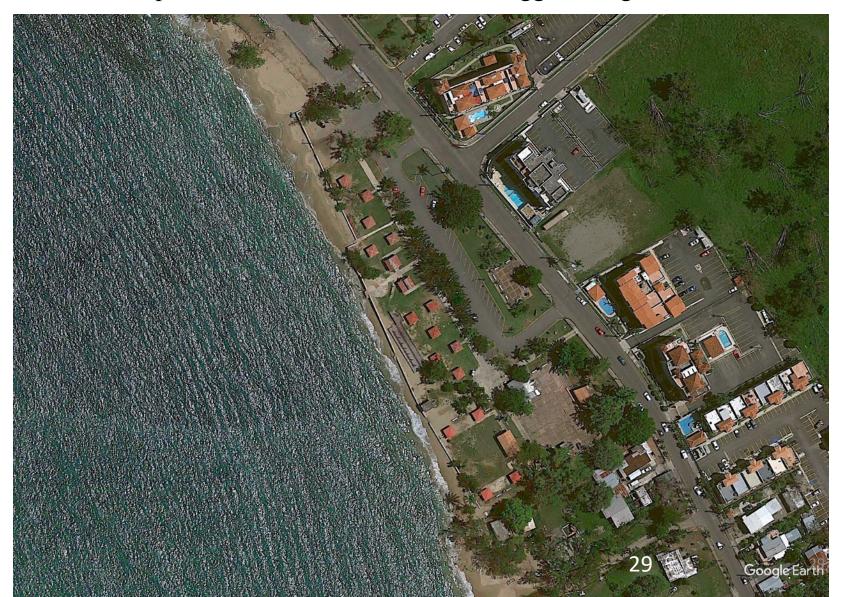
Stop 7: Rincón, Public Beach

Concrete walls replaced the earlier Gabon and are aggravating the erosion at the site.

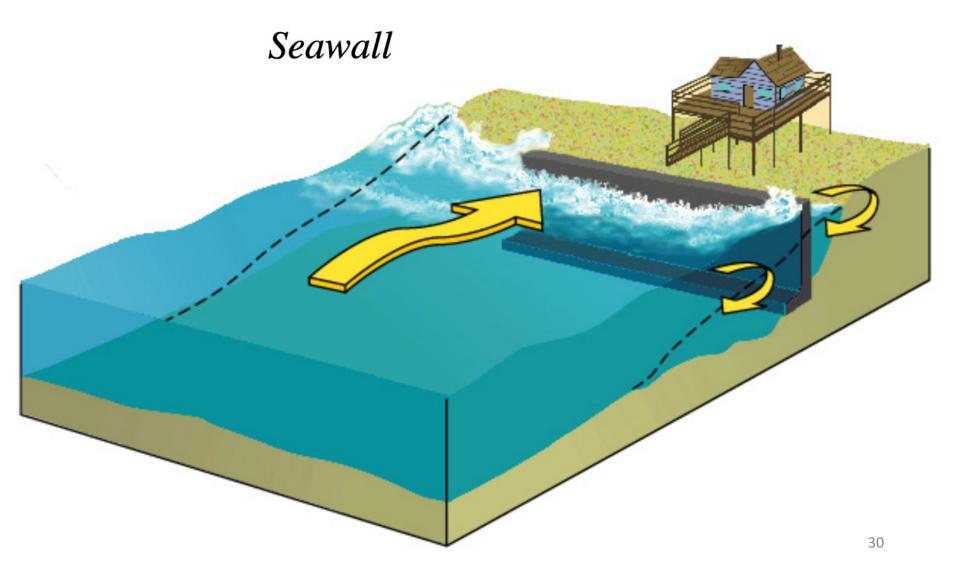
Rompeolas - Muro de Concreto

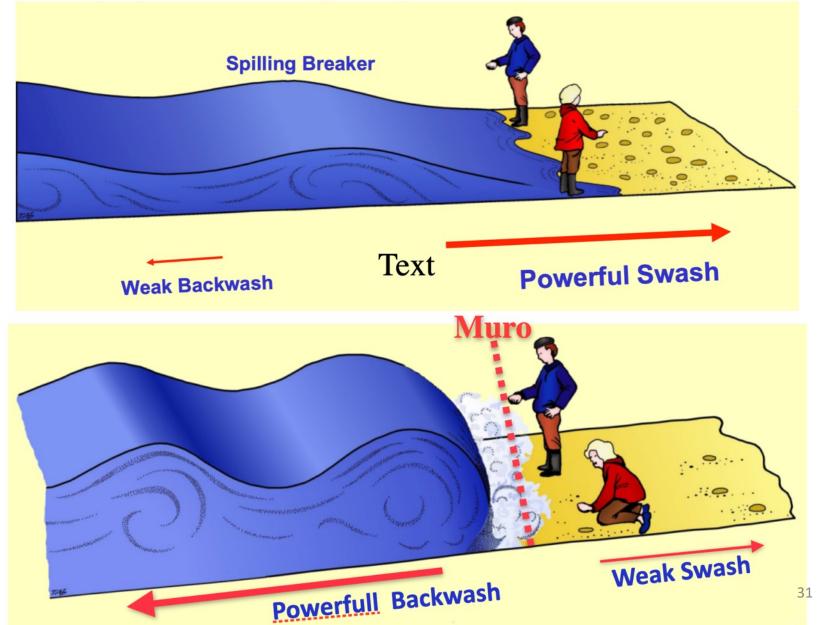
Rompeolas - Muros de Concreto y de Rocas

Protegen la propiedad a corto plazo pero aumentan la erosión en la playa.

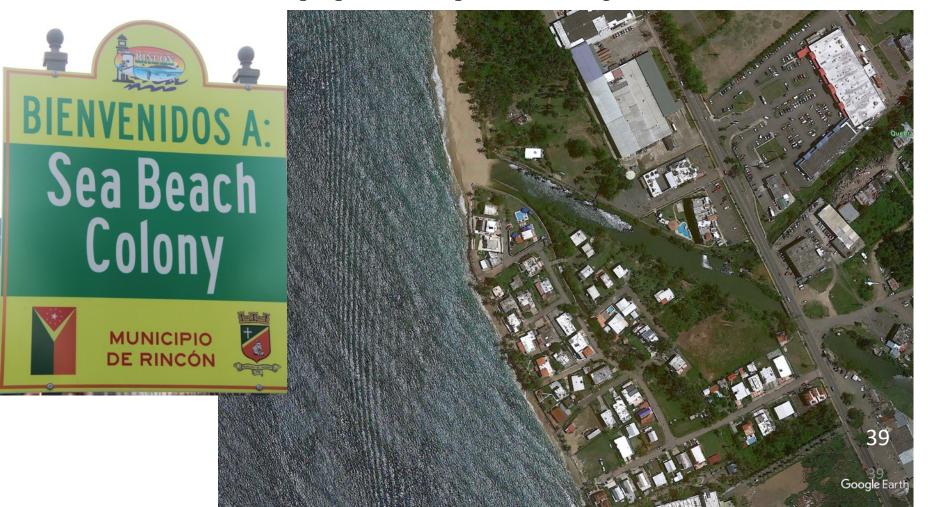
Stop 8: Rincón, Sea Beach Colony Engineered Quebrada Discharge

The jetties at the end of this creek are damaged often and require constant repairs/maintenance. The beach has enlarged to bypass the jetties making them useless. Downdrift erosion in relation to the jetties continues and a rip-rap constructed in front of the beach house properties has produced a high relief at the shoreline.

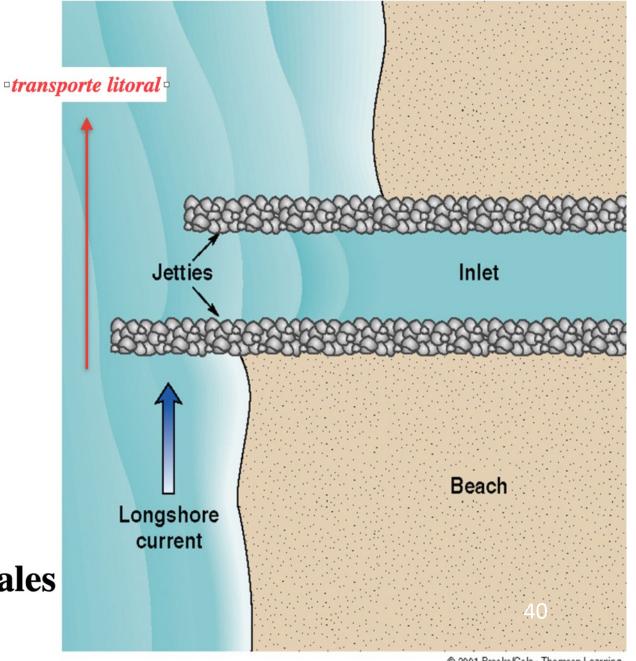
Jetties:

Diferentes a los Espolones en:

- 1. Localización
 - a. Entradas a
 - Ríos
 - Puertos
- 2. Propósito
 - a. Mantener canales abiertos

Espolones para controlar la erosión Jetties para mantener los canales abiertos Grains **Jetties** Harbor entrance transporte litoral Wave crests
