Study of Hurricane Sandy Coastal Impacts and Shorelines changes in New Jersey using Aerial Photographs

Nin-Hernandez, G and Torres-Vázquez, A

University of Puerto Rico, Mayaguez Campus: Physics. Geology and Marine Sciences Building

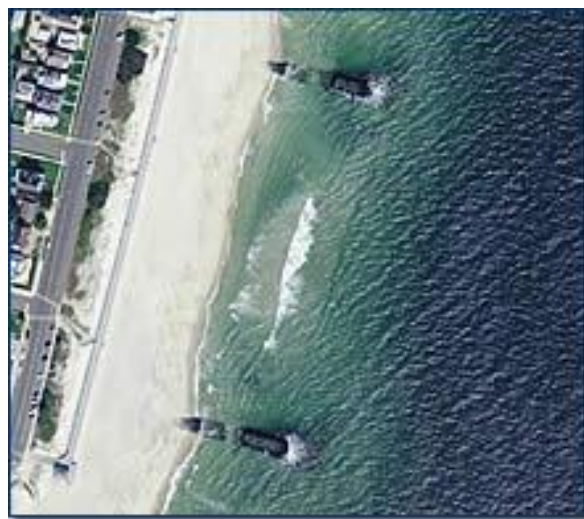
Figure 2: Image showing groins presents along the New Jersey coast. (Image from: Department of Environmental protection, State of New Jersey).

Some geological features present along the coast are groins and barrier islands (Psuty, 1983). Groins (Figure 2) are low

walls constructed perpendicular to the shoreline and function as traps to the transportation of sediments along the long-shore current (Morelock, 2005).

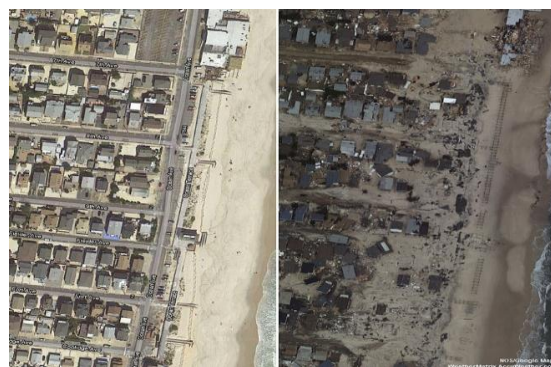
Figure 3: Aerial photograph from New Jersey showing the impacts and changes on the shorelines.

Remote sensing is the science of deriving information about the Earth's surface using images that register reflected or emitted radiation in one or more regions of the electromagnetic spectrum (Campbell and Wyene, 2011). Coastal impacts and shorelines changes are commonly quantified using techniques of remote sensing, specifically aerial photographs (Figure 3).

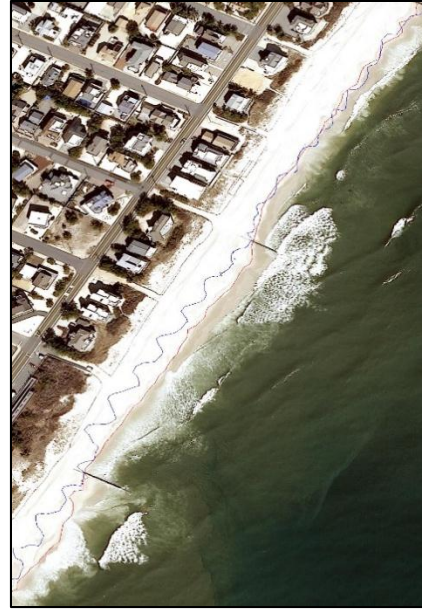
Figure 7: Close-up shot of the shoreline delineation in Long Beach Island. The red line represents the "before" shoreline, the blue line is the "after" shoreline.

The shorelines found before and after the storm showed both erosion and deposition along the beach front (Figure 7). The shoreline measurement after the hurricane also showed signs of dune formation in the beach, another clear sign of high storm surge activity. When the differences between the two shorelines were measured, the average deposition was 15.07 m (Figure 8), while the average erosion was 17.7m (Figure 9). The localization of the erosion and deposition of the beach was determined by the groin features present in the beach; deposition was found north of the groins, erosion was found south.

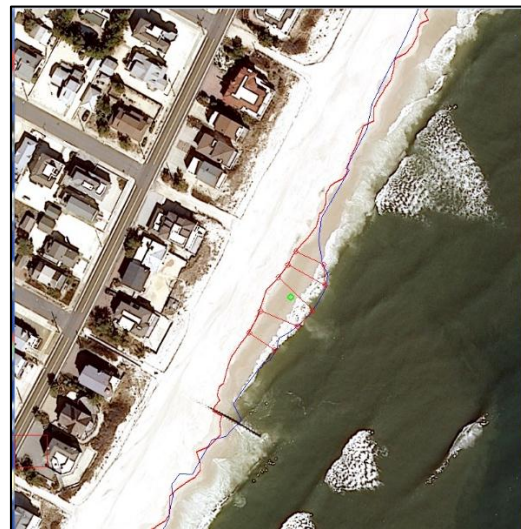
Figure 8: Snap-shot of the deposition measurements. The red line represents the "before" shoreline, the blue line is the "after" shoreline.

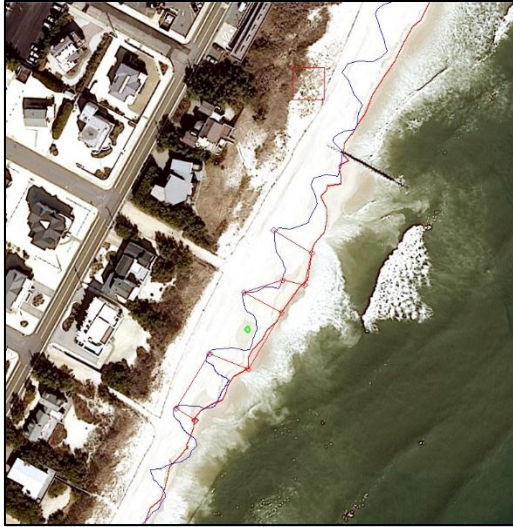
Figure 9: Snap-shot of the erosion measurements. The red line represents the "before" shoreline, the blue line is the "after" shoreline.

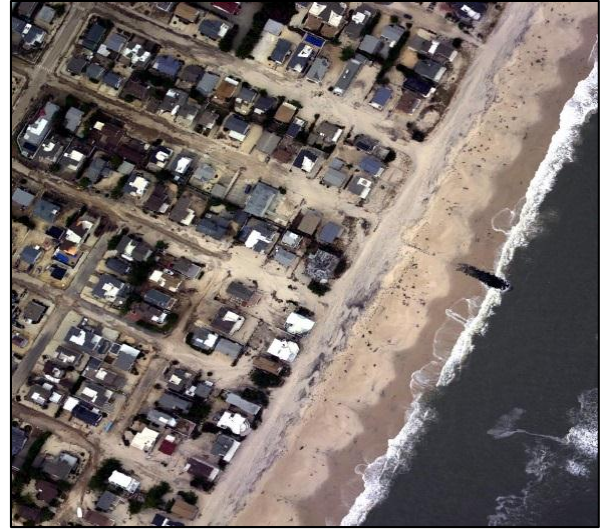
Figure 14: North Long Beach Aerial Photograph taken in March, 2012.

Figure 15: North Long Beach Aerial Photograph taken after the storm, in November 1, 2012.

Similar results were observed when analyzing the second and third locations represented by the images. Both sets of images were taken over Northern Long Beach, New Jersey. The first set (Figures 14 & 15) shows a before image taken in March 2012 and an after image taken on November 1, 2012, two days after the storm made landfall. The aftermath image shows significant storm surge impact: there are visible changes in the location and position of a variety of housing units as well as clear evidence of displaced sand in the residential and commercial areas.

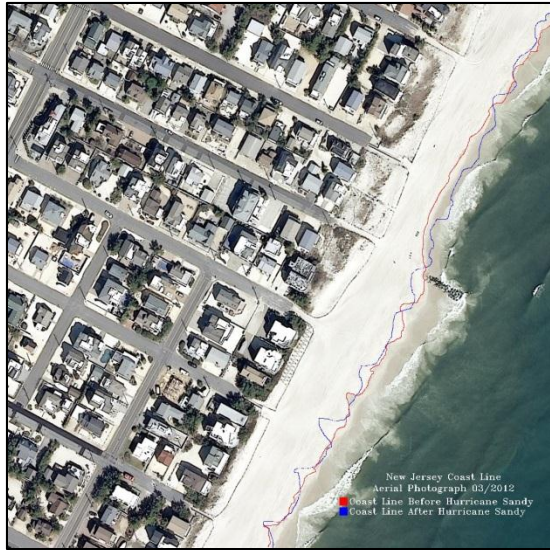
Figure 16: Close-up shot of the shoreline delineation in North Long Beach. The red line represents the "before" shoreline, the blue line is the "after" shoreline.

The shoreline study conducted on this area showed signs of erosion and deposition. There is also evidence of dune formation due to the storm tide, visible in the sinusoidal pattern of the post-storm shoreline (Figure 16).

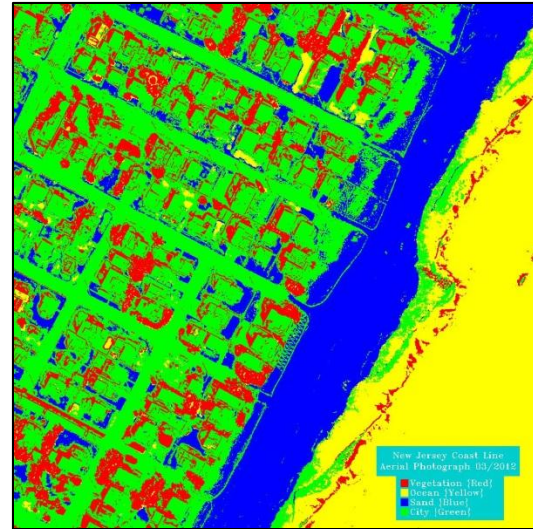
Figure 19: Maximum likelihood classification of North Long Beach image taken on March 2012.

Figure 20: Maximum likelihood classification of North Long Beach image taken on November 2012.

The maximum likelihood supervised classification was more successful in accurately representing the visual elements of the image. The March 2012 classified image shows a remarkable amount of detail that seems to be missing in the post-storm image. Nonetheless, the aftermath image concisely captures the storm surge impact cause by Sandy; sand was deposited along the residential avenues and penetrated hundreds of meters beyond its delineated perimeters.

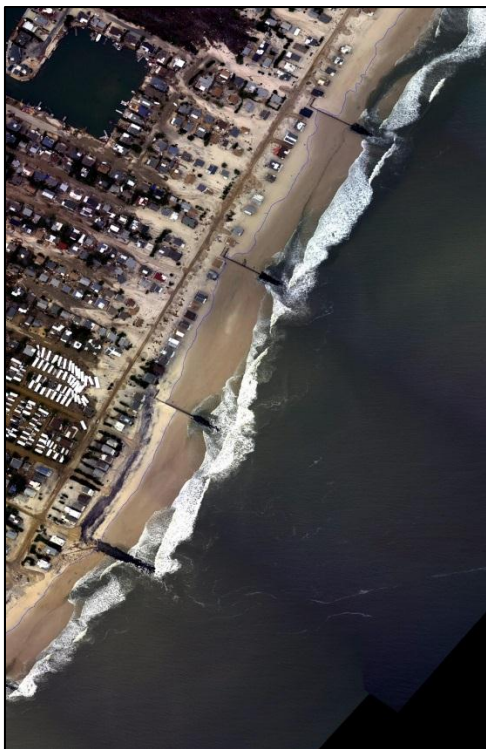
Figure 21: North Long Beach Aerial Photograph taken in March, 2012.

Figure 22: North Long Beach Aerial Photograph taken in October, 2012.

The final image was taken on October 31, 2012, one day after Sandy, and it shows the most damage of the three.

This might be due to the timing of clean up and recovery efforts: in the other two images, the efforts to clean up and restore the area to its previous conditions are more advanced than in this case. This means that, to a certain degree, this image gives the most accurate idea of the true aftermaths of Sandy.

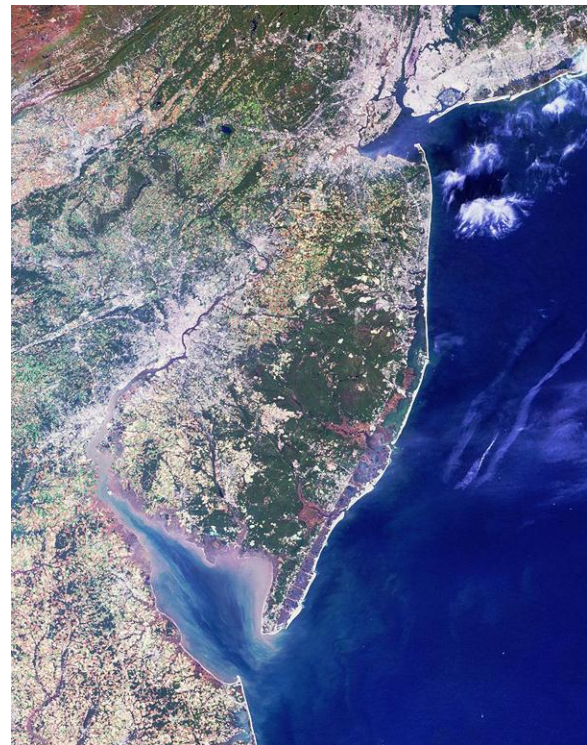
Figure 27: Satellite image showing the New Jersey coastline in 2000.

for longer period (more than 10 years) of time to see global and local changes on sea level. Finally with the purpose of compare these results, process satellite images (**Figure 27**) with the best resolution to see differences on the results.
