Monitoring Shoreline Changes in the North Coast of Puerto Rico in Response to Hard Structures Using Remote Sensing Techniques

JUAN SANTOS ORTIZ

*Department of Geology, University of Puerto Rico, Mayagüez Campus P.O. Box 9017
Mayagüez, Puerto Rico, 00681-9017*

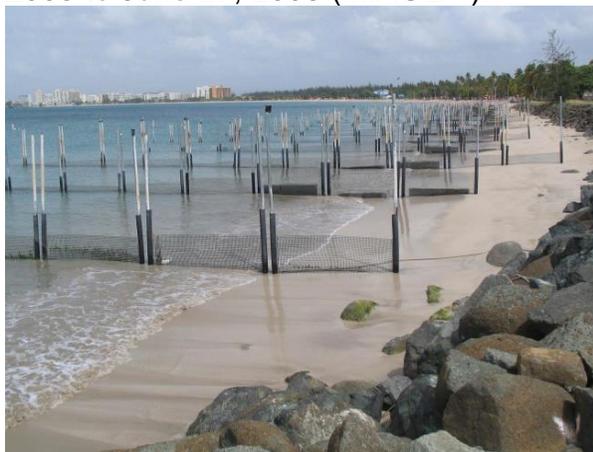
IMAGE 1. NuShore mitigation system approximately 55 groins installed. Source NuShore LLC. Carolina Project Blog 2006)

In Carolina area a project to mitigate erosion was implemented from March 23, 2005 to June 27, 2006 (IMAGE 1).

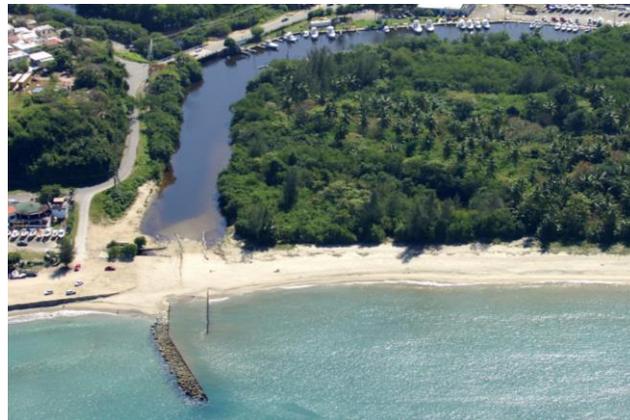
IMAGE 2. Channel close by deposition circa February 13, 2006.
(Source Club Nautico Arecibo 2006)

In Arecibo Bay a navigational channel with a jetty from a nautical club was close due to sediments deposition. (IMAGE 2).

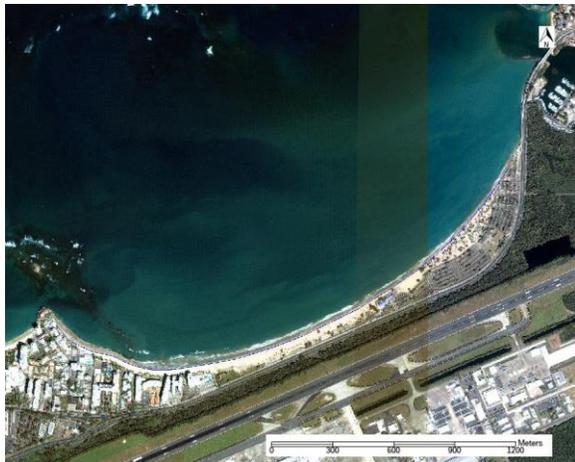
IMAGE 3. Carolina study area (IKONOS 2001)

In this study, 2 beaches of the north coast of Puerto Rico were selected. The balneario de Carolina located in the municipality of Carolina in the coordinates latitude: $18^{\circ}26'47.4''N$ longitude: $66^{\circ}00'07.6''W$ (IMAGE 3) and the Arecibo Bay located in the municipality of Arecibo in the coordinates latitude: $18^{\circ}28'30.3''N$ longitude: $66^{\circ}42'07.3''W$ (IMAGE 4). Both areas have anthropogenic structures impacting positive or negative the sediments behavior in the year 2006.

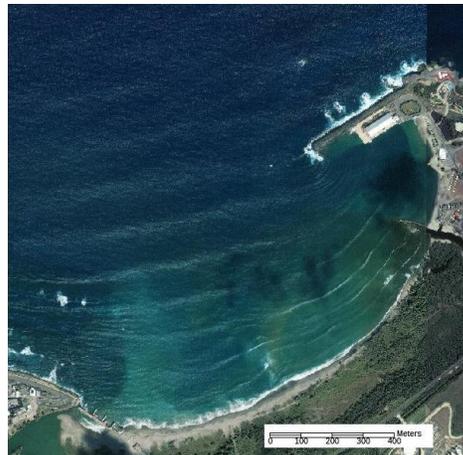
IMAGE 4. Arecibo study area (IKONOS 2001)

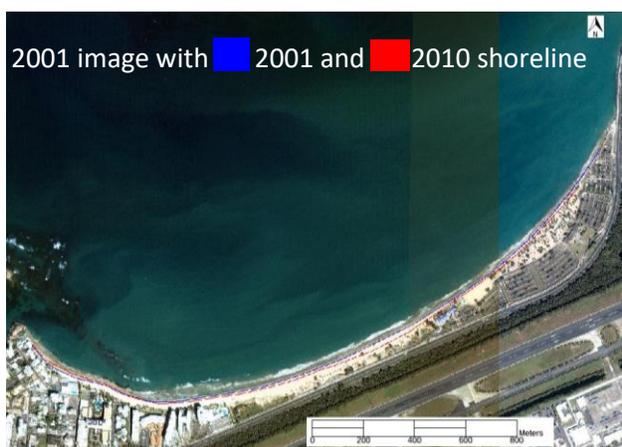
IMAGE 5. Contrast among 2001 and 2010 shoreline in the 2001 Carolina.

Evidently the erosion is in all the Balneario with the highest point at the center. Accretion areas are not present in the Balneario base on the shoreline comparison. Approximately 23,907 square meters of shoreline loss between 2001 and 2010. As seeing on IMAGE 5 and 6.

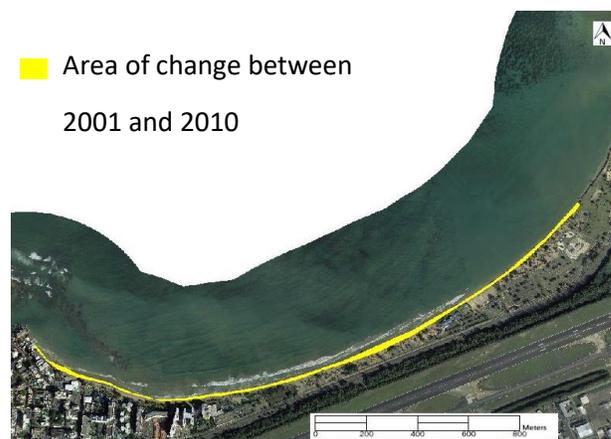
IMAGE 6. Erosion area in Carolina (2010)

The supervised Minimum Distance Classification and the unsupervised Iso Data Classification were used to visualize the shoreline. The unsupervised Iso Data Classification resulted more helpful in delineating the shoreline than the supervised Minimum Distance Classification (FIGURE 1,2,3 and 4). With the unsupervised classification and the image, the shoreline was draw with ROI line in the wet/dry area to delimitate it in both images. Draw a ROI polygon between the difference in lines to calculate the erosion (shortening) or deposition (growing) of the shoreline in square meters (IMAGE 6,8 and TABLE 2).
