REVISTA INTERNACIONAL

DESASTRES NATURALES, ACCIDENTES E INFRAESTRUCTURA CIVIL

Volumen 2021 ● Número 1 ● Diciembre 2021

FAILURE ANALYSIS OF THE ARECIBO OBSERVATORY M4N AUXILIARY CABLE¹

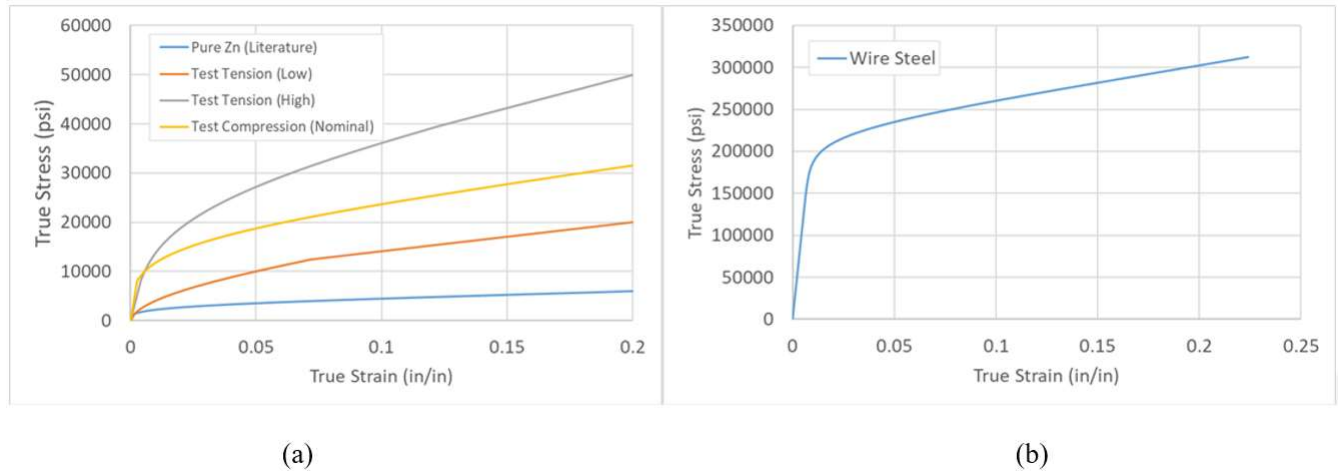
Figure 4: True stress-strain curves for the range of zinc material properties (a) and baseline steel material property (b).

True stress-strain curves were generated and incorporated into the models based on NASA testing of the steel wire and the zinc. Stress-strain curves for the various material systems were approximated using the Ramberg-Osgood method. Pure zinc in structural socket terminations has low tension and high compression strengths, and grain sizes vary based on manufactured method and rates of cooling during casting. A high-confidence material model that accurately reflects both tension and compression response or attempts to model progressive damage is challenging. Zinc properties from material testing also exhibited significant dispersions. Different zinc nonlinear models were used in sensitivity studies to predict socket termination capability to address the uncertainty in the zinc mechanical behavior.

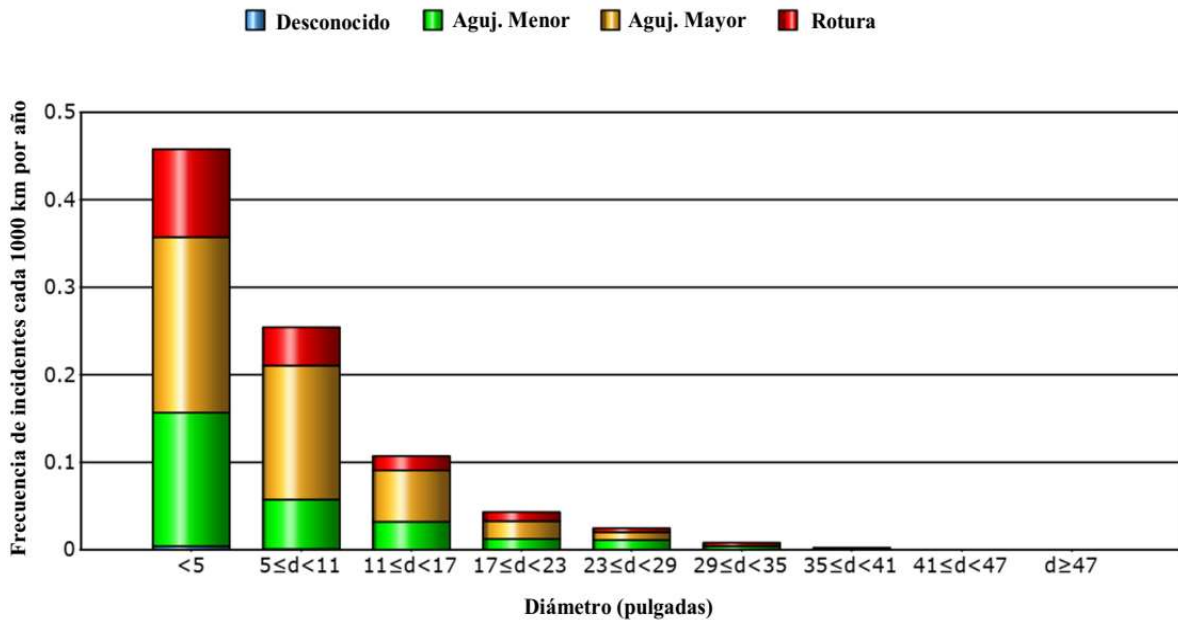
Figura 3: Frecuencia de falla base por daño por terceros Años 1970-2016. (EGIG, 2018)

La Figura 3 muestra la probabilidad de falla base en función del diámetro del ducto y clasificada por los distintos tipos de daño.

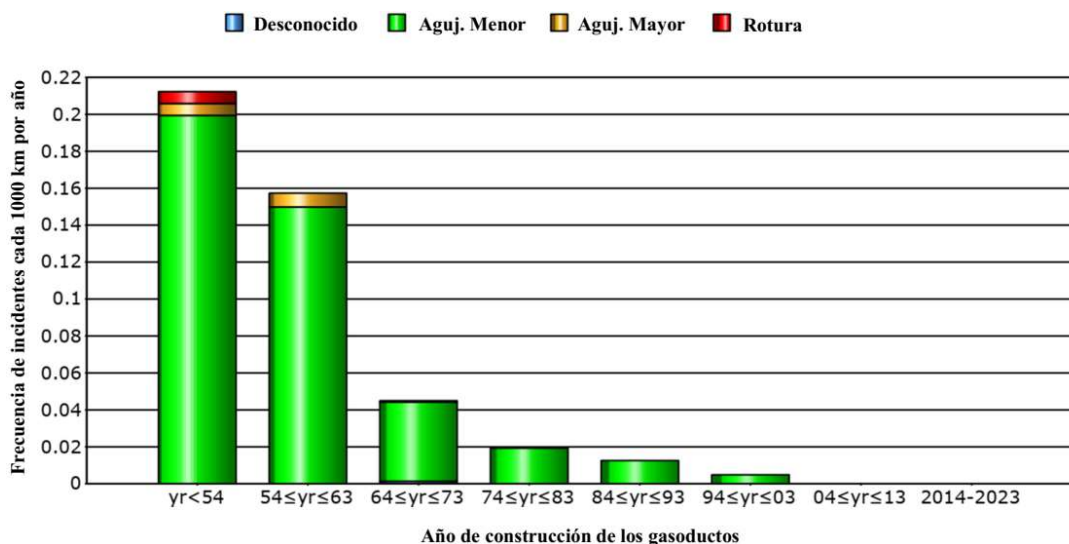
Figura 8: Frecuencia de falla base por corrosión – Años de los reportes de incidentes: 1970-2016. (EGIG, 2018)

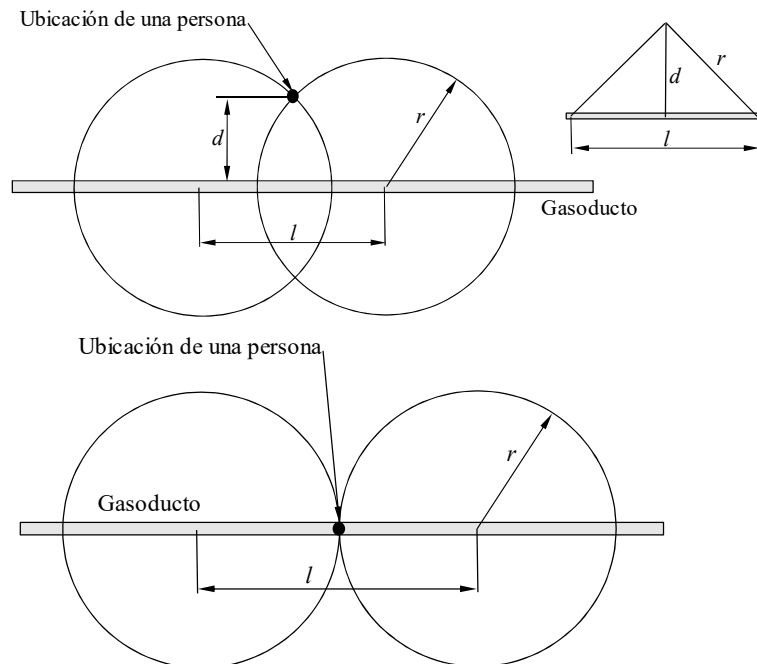
Figura 11: Distancia de interacción para el cálculo de riesgo individual. (IGEM/TD/2, 2015)

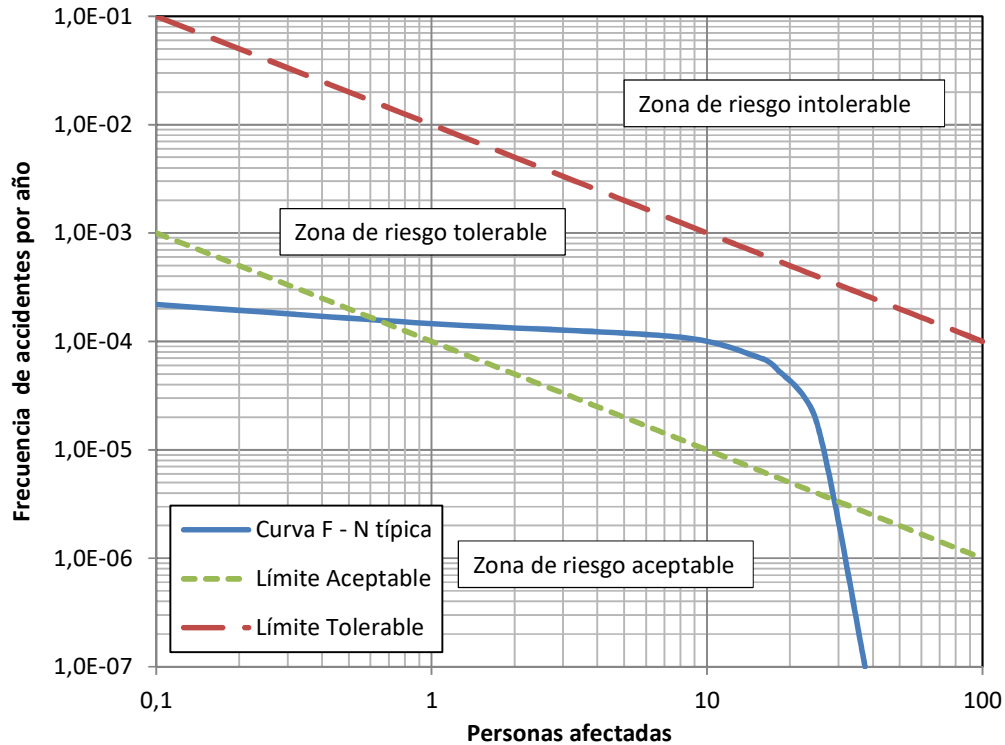
Figura 12: Curva $F-N$ típica para el cálculo de riesgo social. (IGEM/TD/1, 2016)

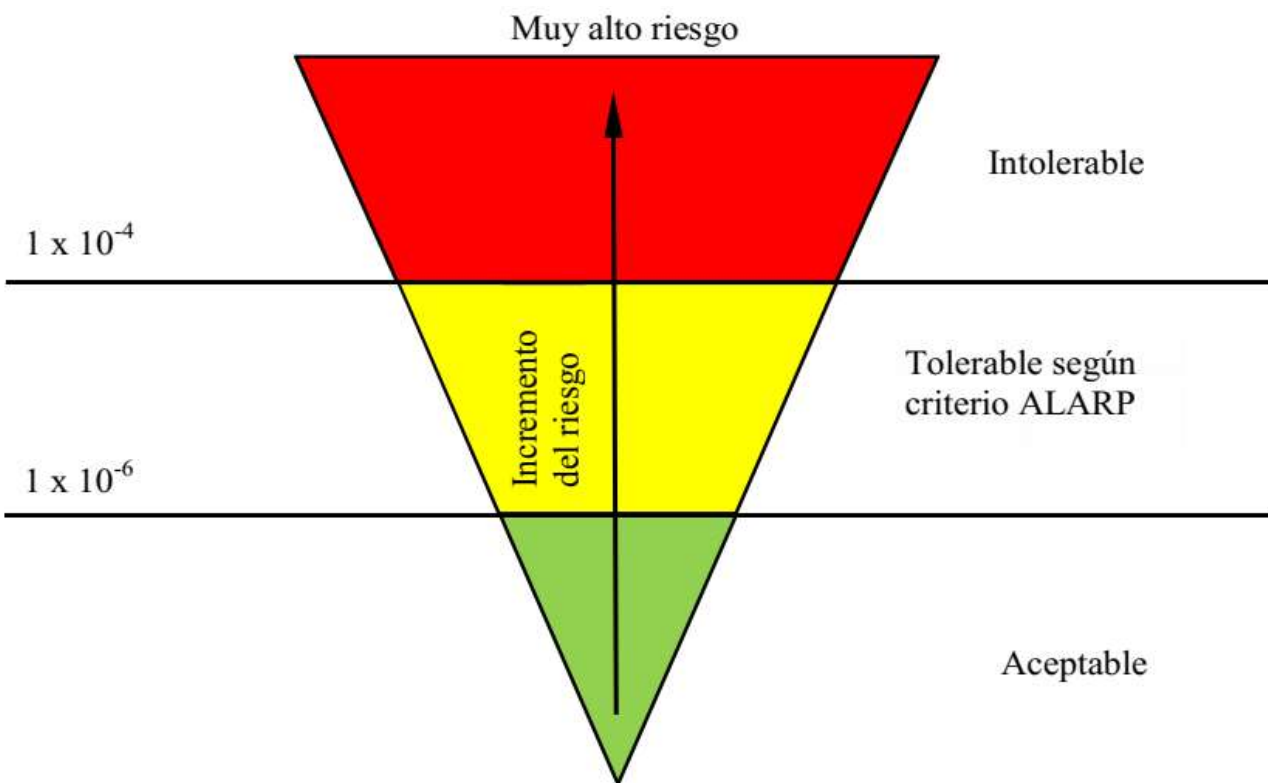
Figura 13: Criterio de aceptación del riesgo individual. (HSE, 2001)

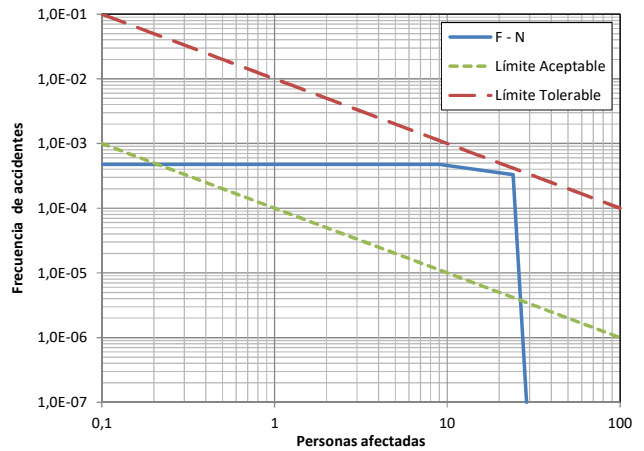
Figura 23: Curva *F-N* de gasoducto 4” en Arroyito (progresiva km 2,475).

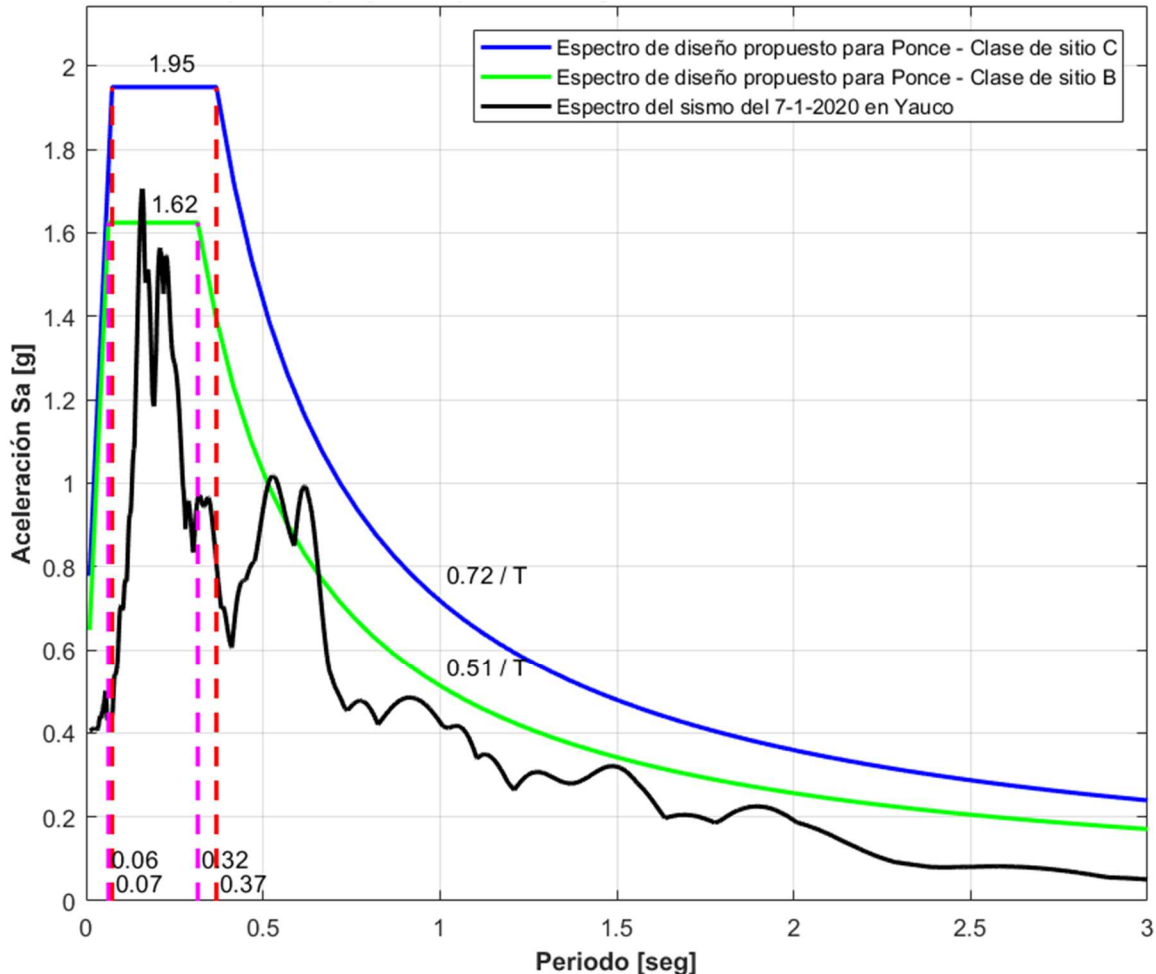
Figura 7: Espectros propuestos para tipos de suelo B y C en el Municipio de Ponce y espectro RotD100 del sismo M6.4 de los registros horizontales para el Municipio de Yauco.

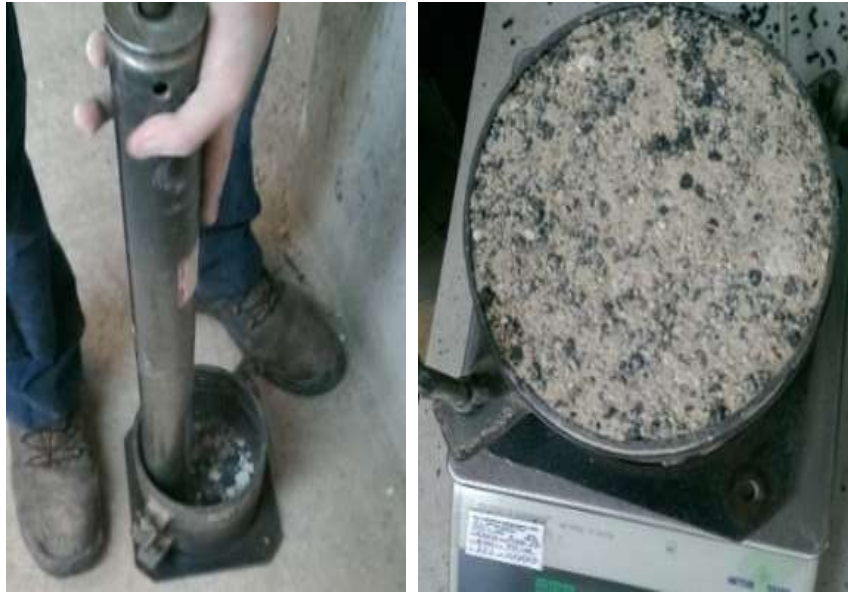
Figure 6: Mix #1 compaction test process. (MGV-GES LAB)

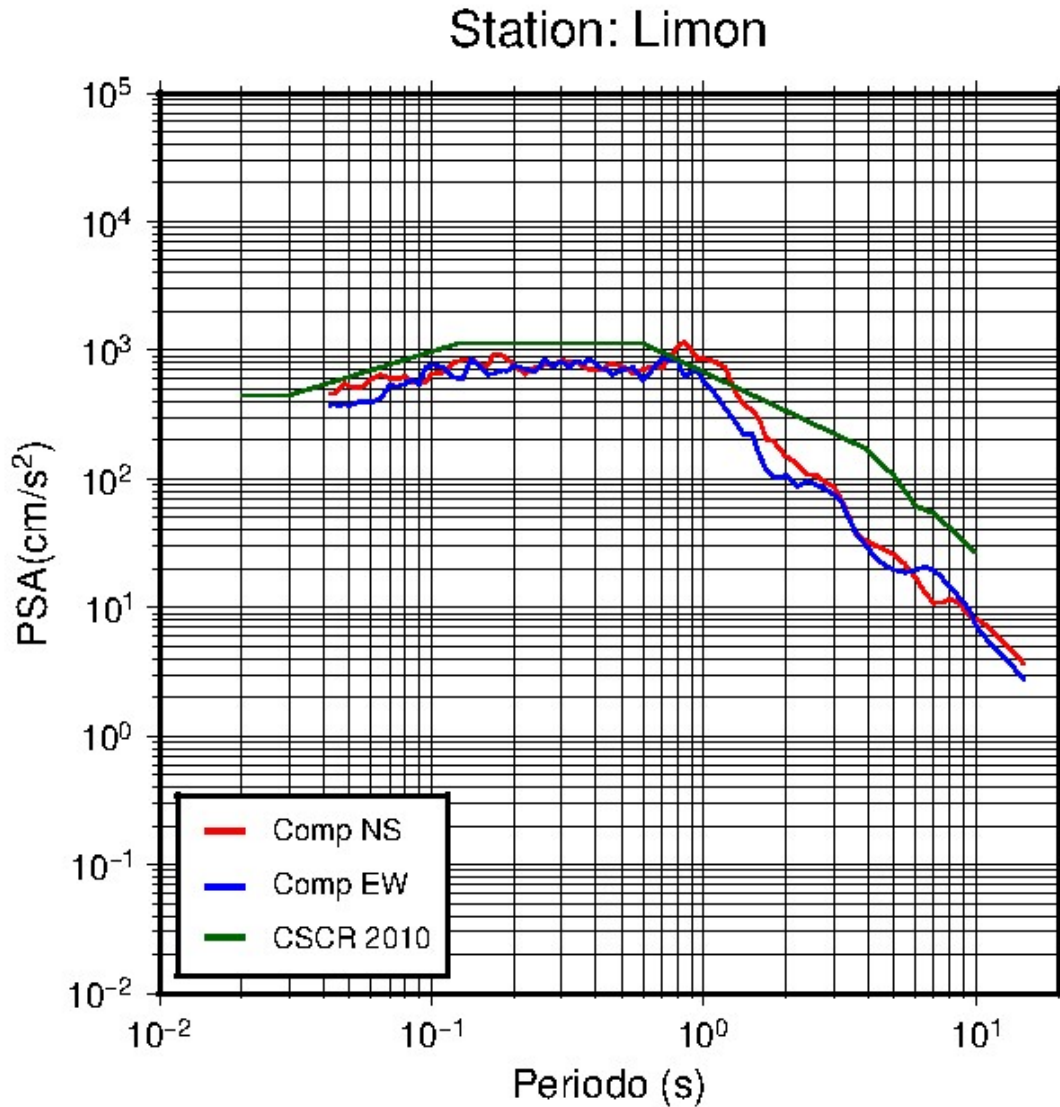
Figure 6: Design spectra (green) and synthetic NS (red) and EW (blue) for at the city of *Limón*.
