Using Aerial Photographs to Compare Coastal Erosion in El Maní at Mayagüez, Puerto Rico, between 1930, 1999 and 2010

University of Puerto Rico at Mayagüez, Department of Geology

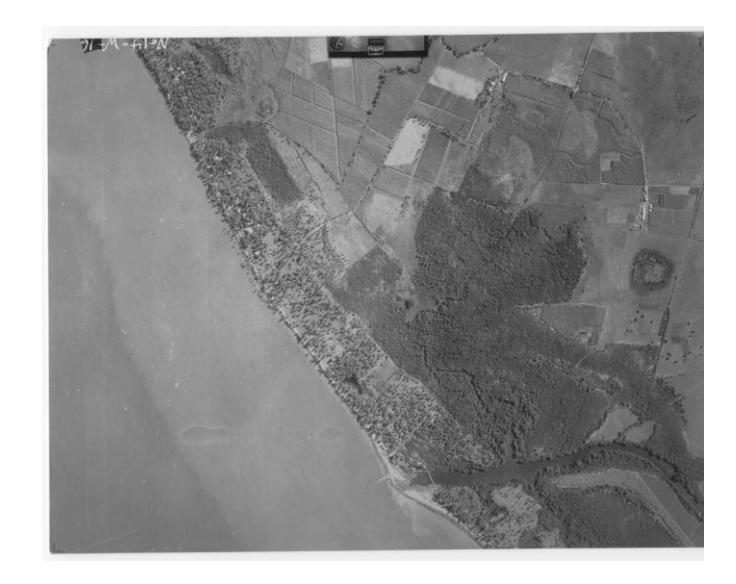
Image 2: 1930 black and white aerial photo (raw) from El Maní at Mayagüez, Puerto Rico.

For this research, aerial photographs were obtained from different databases depending on the chosen study year. Photographs from 1930 and 1999 were freely available at the Porto Rico 1930 Aerial Image Database website (http://pr1930.revistatp.com/) and the CCMA: Center for Coastal Monitoring & Assessment website (http://www8.nos.noaa.gov/biogeo_public/a erial/search.aspx) respectively. Dimaris Colón, current graduate student at the University of Puerto Rico at Mayagüez, provided the required aerial photograph from 2010. The selected aerial photograph from the starting point, 1930 was available in black and white and characterized by a very low resolution due to the year the photograph was taken (Image 2) while images from 1999 and 2010 were in true color and with a clearly shown, better resolution (Image 3 and Image 4).

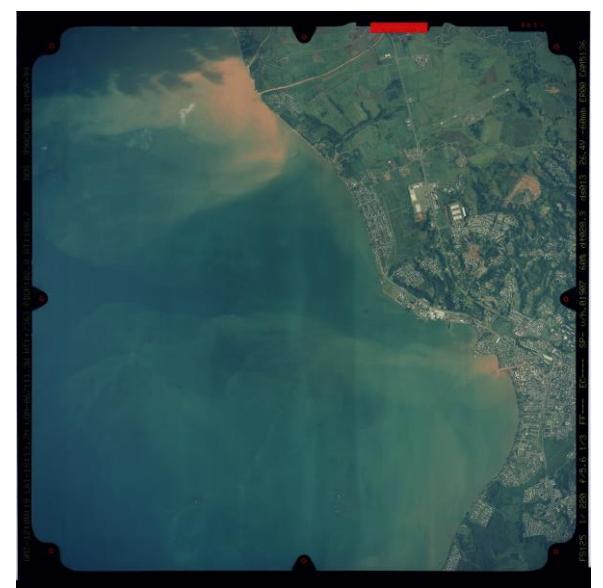
Image 3: 1999 true color aerial photo (raw) from el Maní at Mayagüez, Puerto Rico.

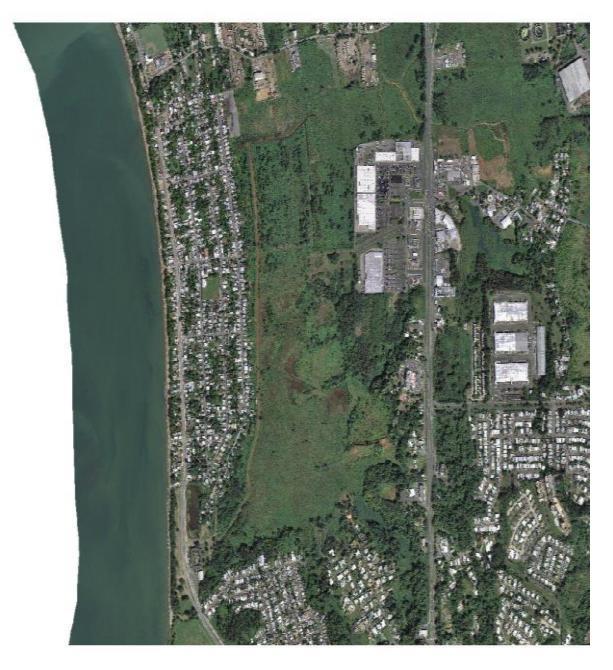
Image 4: 2010 true color aerial photo (raw) from el Maní at Mayagüez, Puerto Rico.

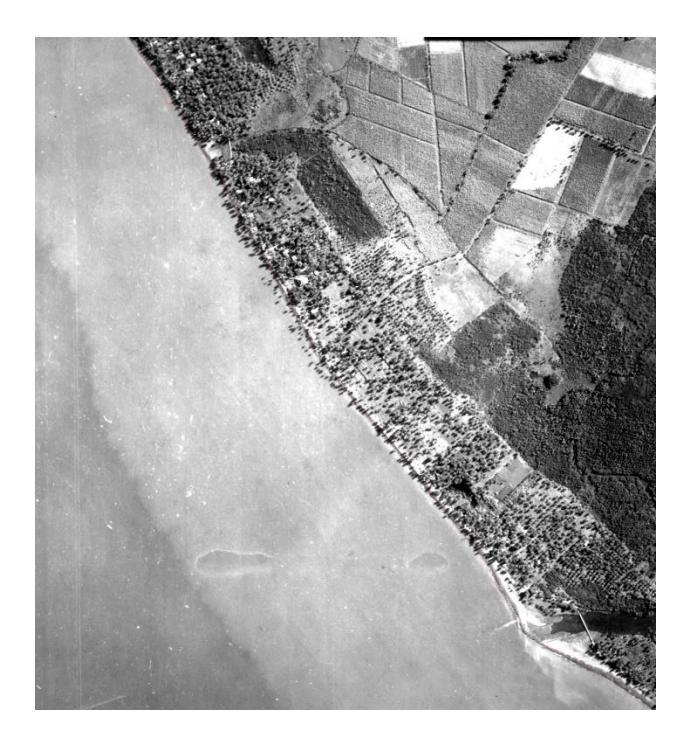
Image 5: 1930 aerial photo from El Maní.

The coastline is traced in red.

Images 5 - 7 shows aerial photographs from El Maní in Mayagüez, Puerto Rico after being processed in the ENVI software to identify coastline changes. As previously discussed, due to the low resolution of the 1930 photograph, the coastline was traced based on the black and white differences. Image 5 shows a spatial subset of the raw 1930 aerial photograph with its coastline trace in light red. For the 1999 and the 2010 it was easier to trace the coastline image 6 shows a spatial subset of the 1999 aerial photograph with its coastline traced in blue while image 6 shows a spatial subset of the 2010 aerial photograph with its coastline traced in purple.

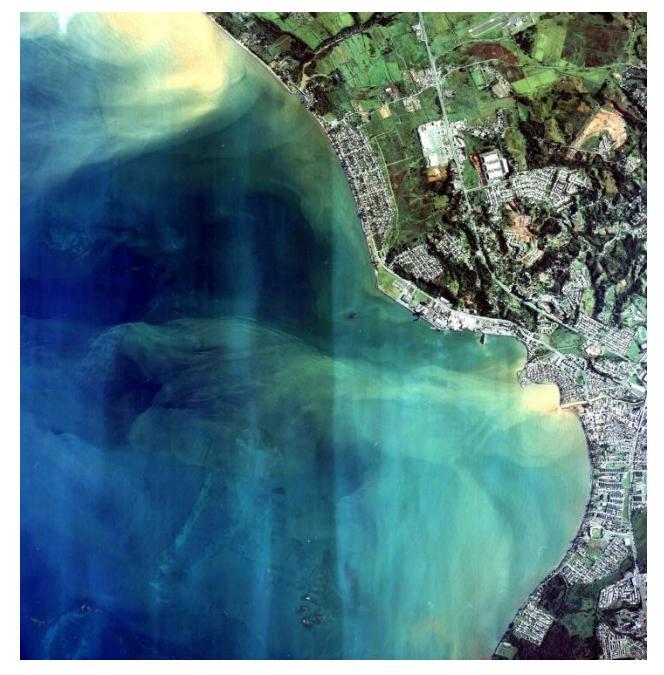
Image 6: 1999 aerial photo from El Maní. The coastline is traced in blue.

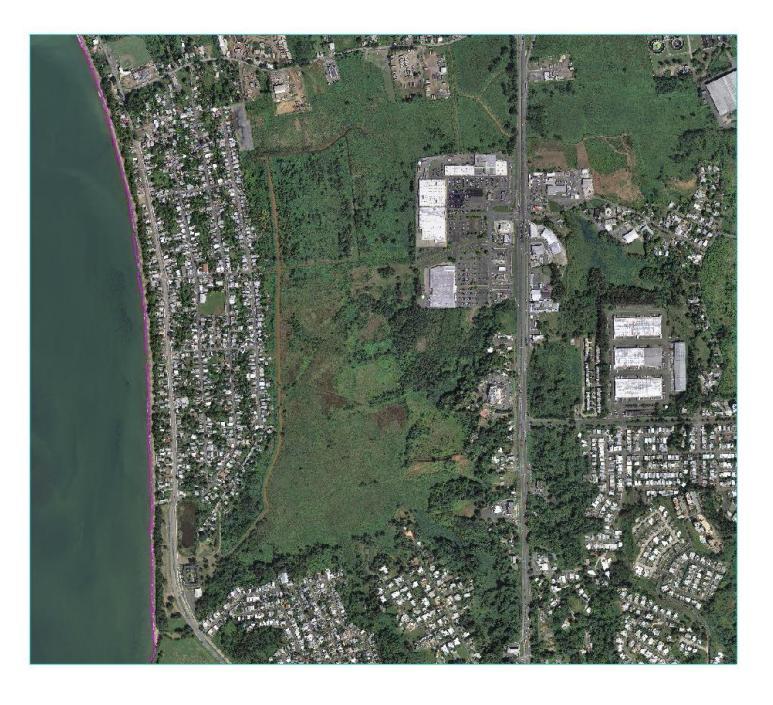
Image 7: 2010 aerial photo from El Maní. The coastline is traced in purple.

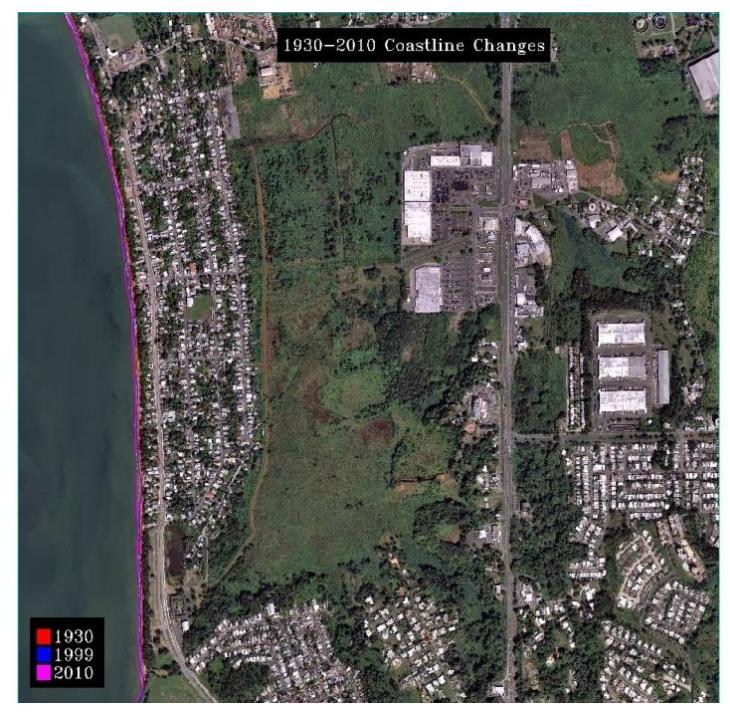
To better visualize coastline changes, the ROI files containing the 3 traced lines where merge to create coastline a mosaic. Image 8 shows the coastline for the 3 selected years (1930, 1999 and 2010). With this mosaic we observed that this coast shows was a depositional patter. This could be due to it nearness of 2 river mouths, Añasco y Yagüez.

Image 8: Mosaic of coastlines from 1930,1999 and 2010.

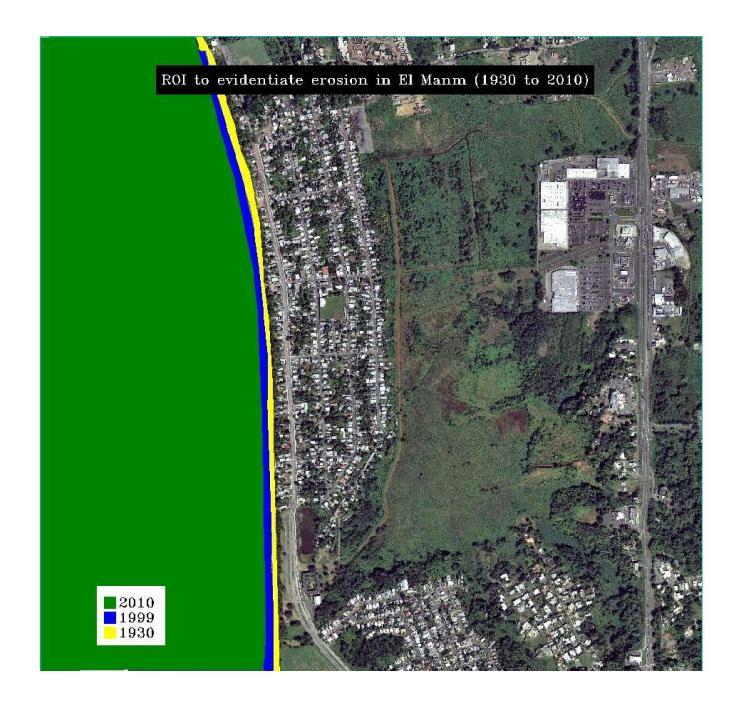
Supervised classification, specifically maximum likelihood, with 3 classes was run in the 1999 and 2010 photographs. The specific classes were city, vegetation and ocean. Image 9 represents a depositional scenario for El Maní coastal area. The green color is the present beach (2010), blue color shoreline, and yellow represents 1999 1930 shoreline. Image represents 10 corresponds to the supervised classification for 1999 and Image 11 corresponds to supervised classification for 2010. Both classifications were verv accurate specifically classifying changes in infrastructure (city class). It was expected to see a reasonable change in infrastructure, but comparing both images, this cannot be hypothesized. It has to be studied from upper regions (higher elevations), different from the coast area, in order to see if changes that could be contributing to the depositional features, can be identified.

Image 9: ROI file showing deposition in El Maní, from 1930 to 2010.

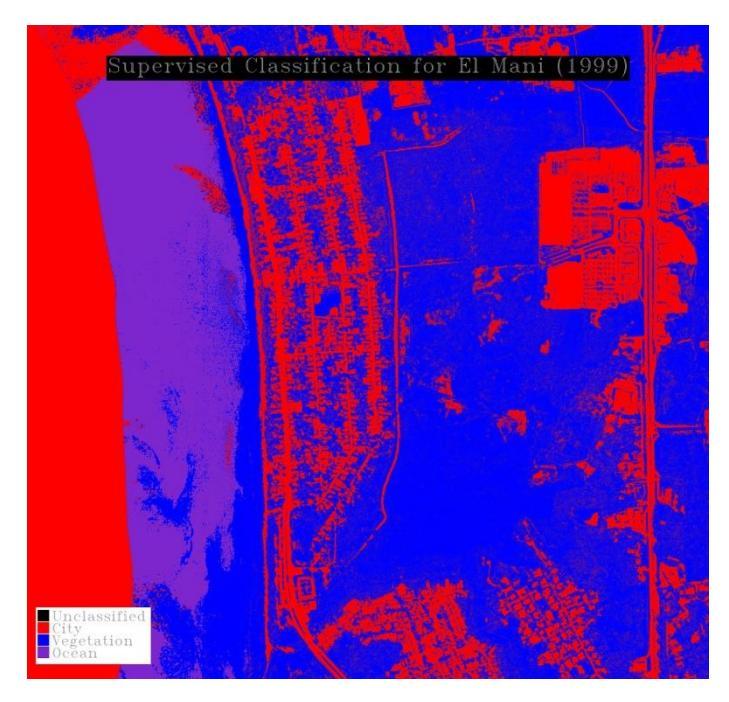
Image 10: Supervised classification, Maximum Likelihood for El Maní 1999 aerial photograph.

Supervised Classification was the tool that allowed the traced coastlines to be validated. Due to the lack of resolution of the 1930 photograph it was not possible to perform the classification in this image. Maximum Likelihood classification was run in the 1999 and 2010 photographs, using a ROI file including 3 classes (city, vegetation and ocean).

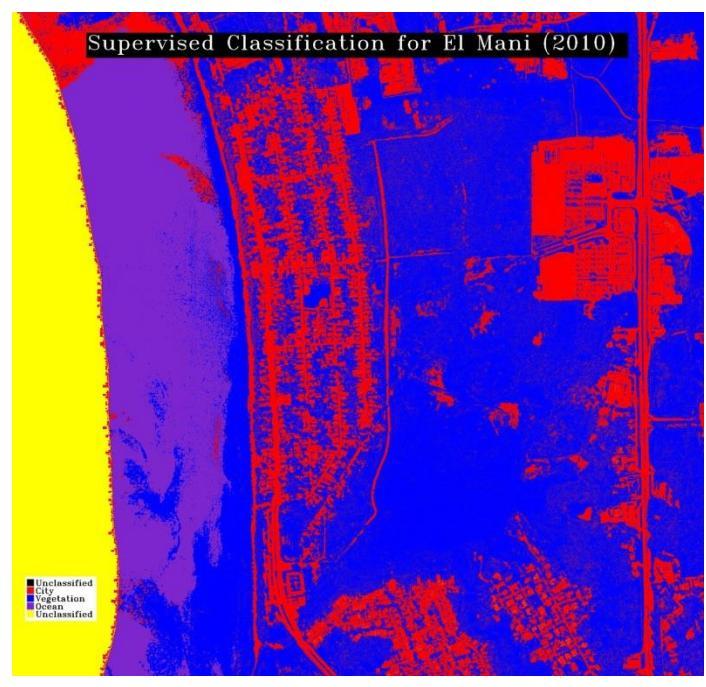
Image 11:Supervisedclassification,Maximum Likelihood for El Maní 2000aerial photograph.
